EARTHQUAKE HAZARD CENTRE NEWSLETTER

Vol. 20 No.2

OCTOBER 2016

Summary of Damage Observed in Tarqui, Manta

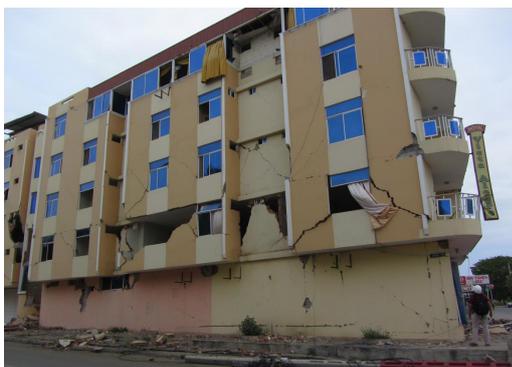
Hotel Vista Alegre

- 5-storey RC frame building with masonry infill walls
- Extensive wall damage
- Walls fell out after in-plane failure

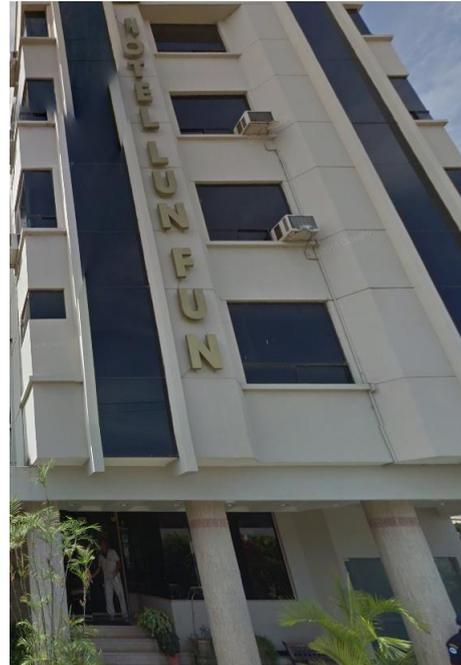
*Before earthquake.
Higher ground floor height to soft storey.*

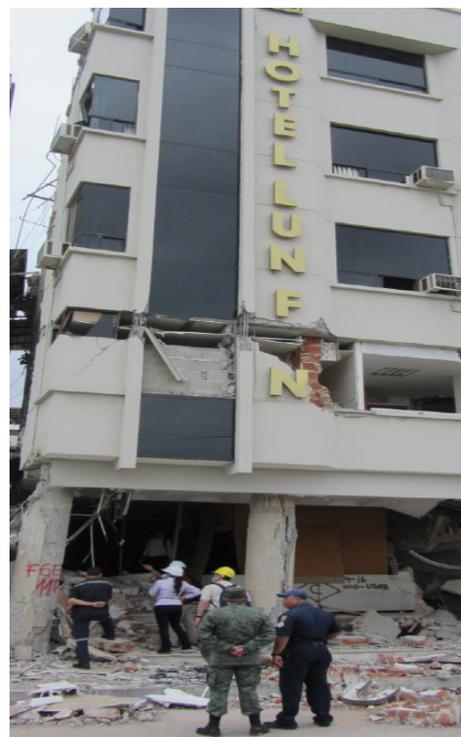
After earthquake. Note rectangular column on typical floor but circular on ground floor.

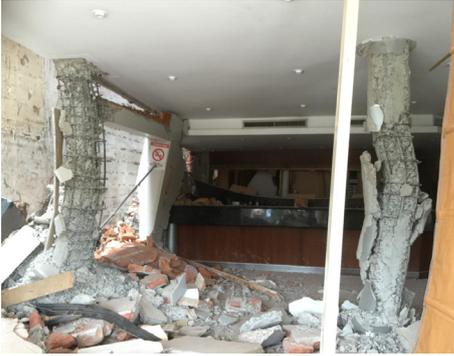
Poor concrete quality. Unreinforced masonry wall not braced. Inadequate concrete confinement. Note rectangular rebar cage for round column.

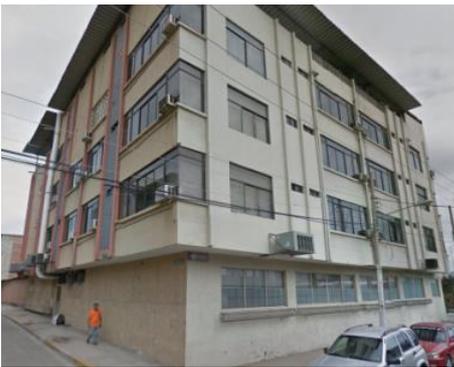
11th Ave and 2nd St

Before earthquake. Note typical floor hangs over sidewalk. Higher ground floor height soft storey.

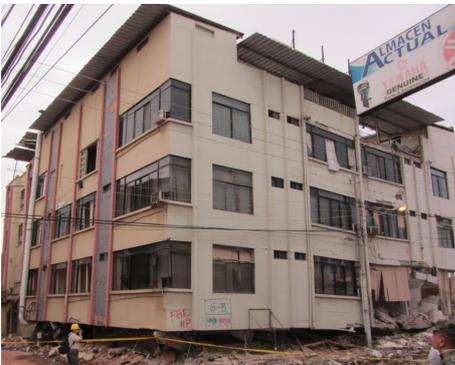
*After earthquake
Complete collapse of ground level.*

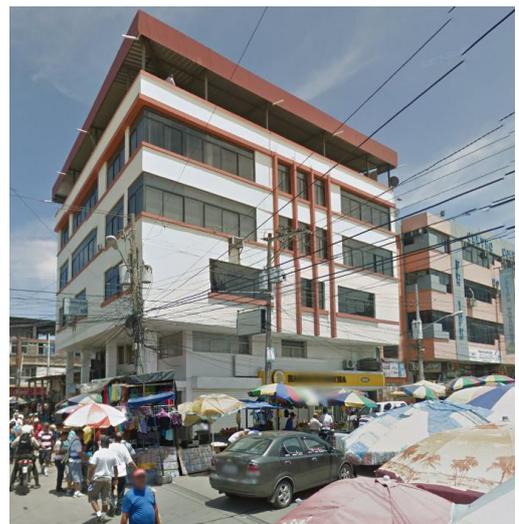
Before earthquake. Higher floor height - soft storey.

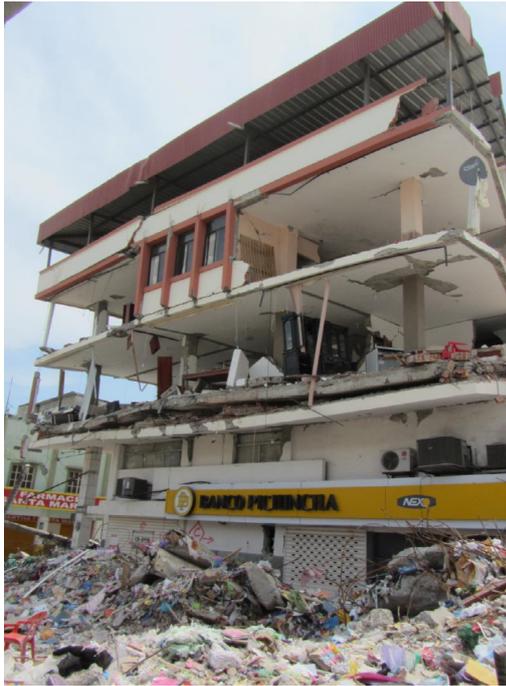
After earthquake. Storey collapse.

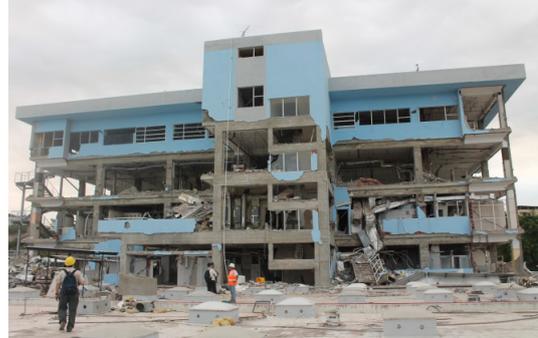
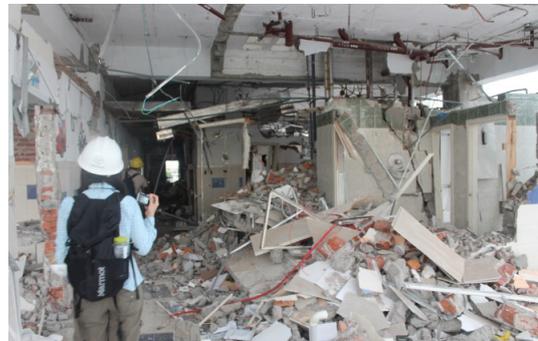
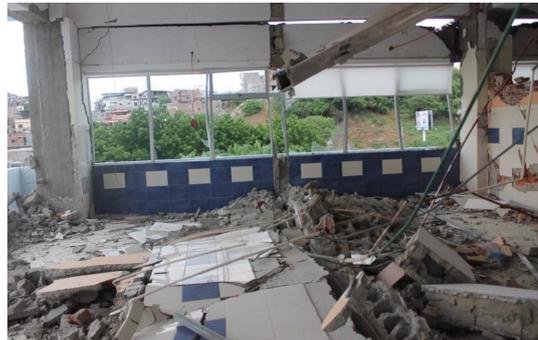
Hospital IESS (Manta)

- Severe cracking or total collapse of several interior and exterior walls made of unreinforced masonry
- Lack of proper attachment for mechanical equipment

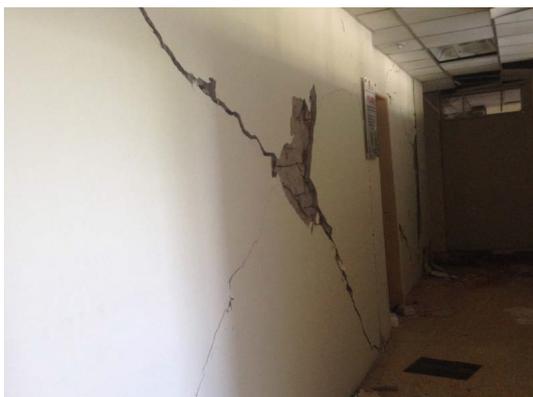
Severe cracking of URM walls was observed in the 1st floor; however, several of these walls did not fall down towards the ground. Smaller drifts due to rigidity of shear walls might have influence on this behaviour?

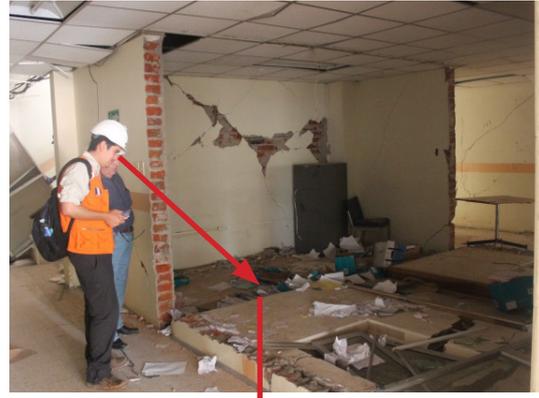
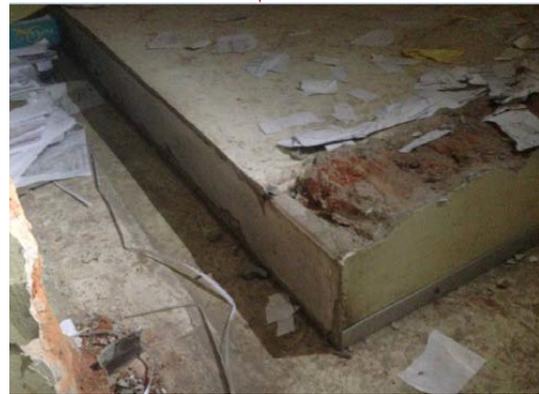
No attachment of partition wall

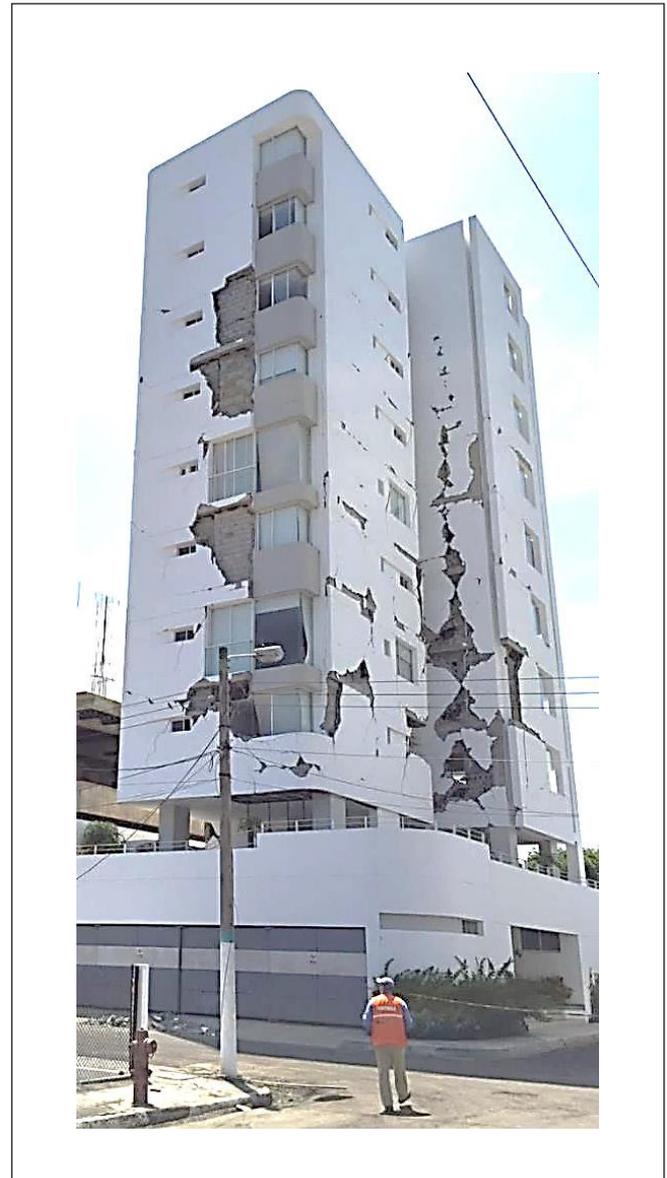
- Due to inadequate anchorage to main structure masonry cladding frequently toppled and fell to the ground
- Or else due to lack of reinforcement cladding disintegrated
- Cladding failure is of course, a very serious threat
- Both at ground and for the inhabitant
- Again, due to lack of reinforcement and inadequate anchorage to main structure

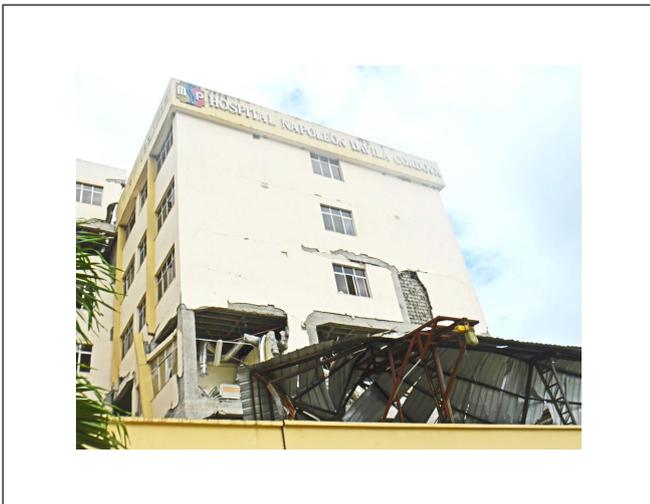
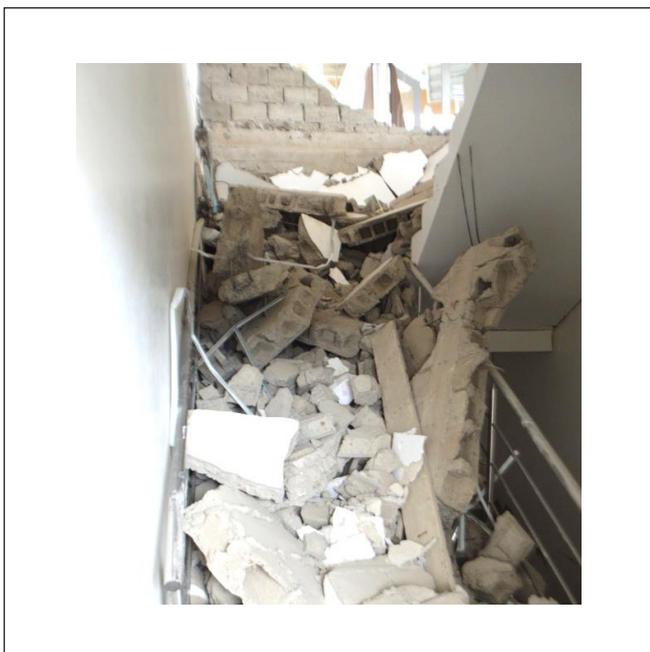
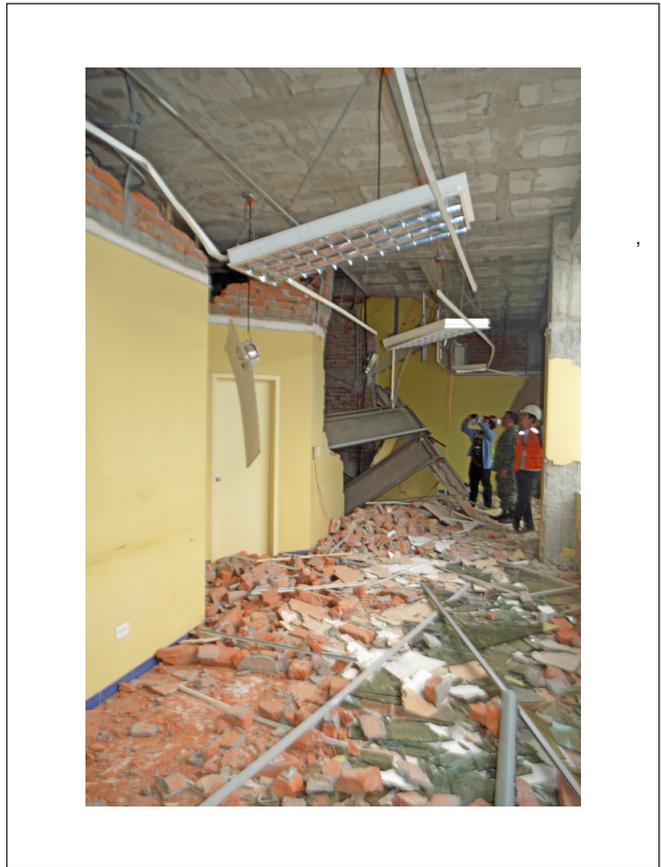
- Masonry partitions and cladding are brittle and too stiff for the typical building
- This type of masonry starts to crack with a few millimetres of in-plane storey displacement while the “typical” building frame can be shown to start yielding at 2 cm inter-storey displacements
- If the masonry is under-reinforced it disintegrates at the design EQ loading
- Even if partition is permitted to “slide” while prevented from toppling it is usually very difficult to achieve effective displacement isolation
- For claddings a more flexible system or a panelled solution is necessary
- But before trying to “perfect” or “rescuing” the masonry system there is a more fundamental step to take

- For the architectural usages in Ecuador and other Latin American countries stiffer structures are needed.
- It is necessary to use resources such as shear walls to laterally stiffen the buildings (and to increase strength reliability)
- In the presenter’s view, only when stiffer structures are built should the issue of proper non-structural seismic design be addressed
- It is not only the partitions and cladding which are threatened by too flexible structures, hanging ceilings are a threat, especially in large, high rooms
