# EARTHQUAKE HAZARD CENTRE NEWSLETTER

Vol.15 No.4

APRIL 2012

## A summary of “the EERI Special Earthquake Report - April 2012 - The $M_w$ 7.1 Erciş-Van, Turkey Earthquake of October 23, 2011”, by Rafael Alaluf, Ricardo Hernandez, Cemalettin Dönmez and Ayhan İrfanoğlu.

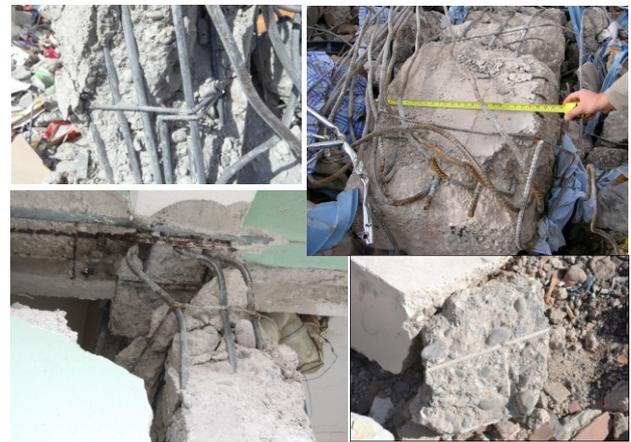
Fig. 4 Examples of deficient reinforcement detailing, poorly graded concrete mix, substandard concrete casting (photos: Alaluf, Dönmez, İrfanoğlu, METU group).

hooks in transverse rebars, use of smooth rebars, improper splicing of column longitudinal reinforcing bars, poorly graded concrete mix design, and substandard concrete casting (Fig. 4). Apparently, the new RC structures were designed by engineers, but they had no quality control during the actual construction of the building. Our local contacts noted that the construction process had become so informal that land owners would hire separate local specialty workers (for formwork, rebar placement, concrete casting) and not even hire a contractor to organize the process. Few, if any, inspections or quality control checks were done.

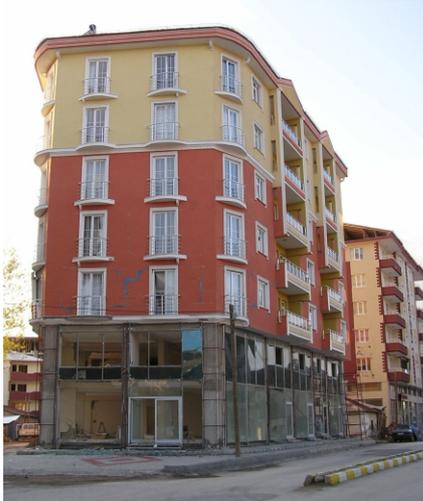
Fig. 6 Heavily damaged RC structure with tall ground story (photos: Dönmez, İrfanoğlu).

side of the buildings. Such a structure can be seen in Figure 6.

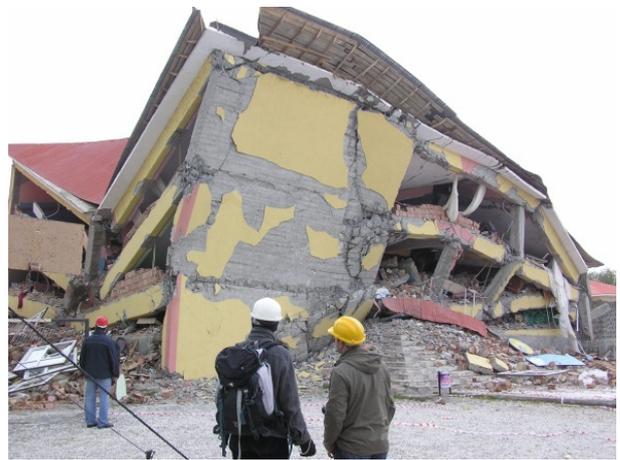
In Gedikbulak, a large village with 250 buildings located about 15 km NW of the October earthquake epicenter, a three-story primary school building with structural walls collapsed during the earthquake (Figure 7). The building, constructed in 1988, had an approximately 14.4m x 21.4m footprint. It had two 7.2m x 0.3m structural walls along its plan long direction built on one end of the building and only columns, some of which were captive, at the other end. Two 4.6m x 0.3 m structural walls bordering the stairwell, which was near the centerline, acted as the main lateral load-resisting elements in the plan short direction. The seven 0.5m x 0.3m columns around the building perimeter were the sole vertical structural elements along one half of the building front, although four 0.3m x 0.3m interior columns were also present. The collapse configuration evidenced floor torsion as it appeared that the building twisted in plan as it slumped.

Fig. 7 The three-story primary school in Gedikbulak village after collapse (photos: Erdil, İrfanoğlu).

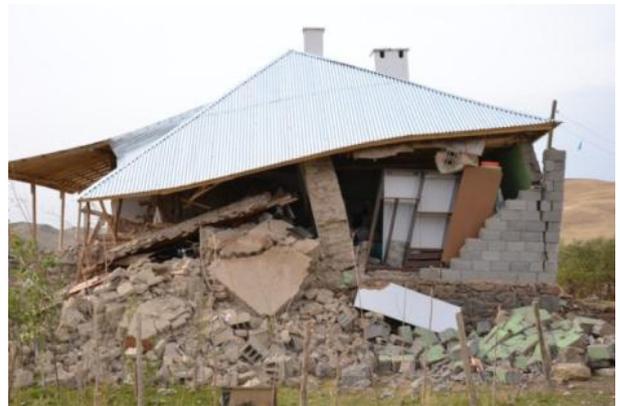
roofs with light gage metal covers. Most of these structures survived the earthquake with no damage, an indication that their elastic limits were not exceeded. Buildings in villages are constructed typically as bearing-wall structures using concrete masonry units, bricks, or rocks. The typical failure mode in these structures was out-of-plane wall failure due to the absence of diaphragms tying the walls together (Figures 8 and 9).

Fig. 8 Typical out-of-plane failure of concrete masonry unit bearing walls (photos: Alaluf and Bedirhanoğlu).

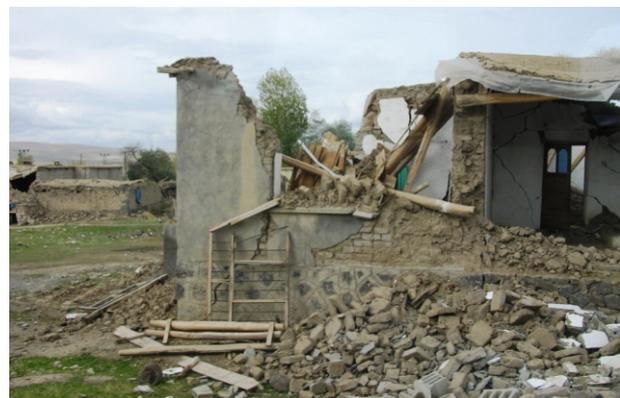
Fig. 9 Failure of mud brick bearing walls in Gedikbulak village (photo: İrfanoğlu).

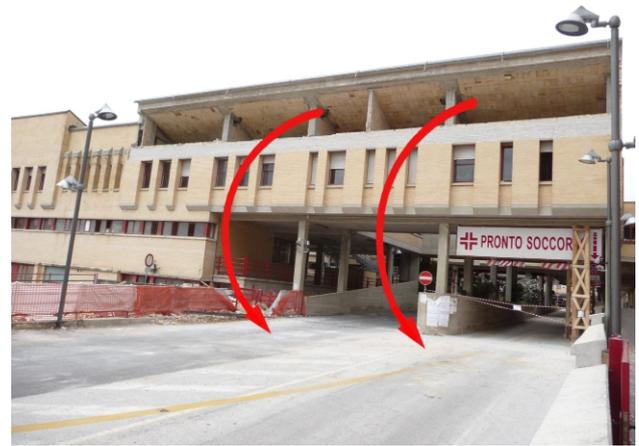
*Fig. 10 Location of collapsed masonry infill and veneer from above the entrance portico (the debris had been cleared away at the time of visit).*

performed adequately, especially if one compares the ground motion intensity to the design loads, with significant damage limited to isolated columns in three structural units on the campus (Fig. 10).

Several lower-level columns (four to eight in total) comprising the entry portico of the main entrance and emergency entrance suffered partial failure without collapse or noticeable deflection at the tops of these frame elements. The concrete cover at these locations spalled, the inner concrete core of the column appeared to have a slight offset, and the vertical reinforcement was exposed and buckled (Fig. 11). Column tie reinforcement was not observed and appears to be either very widely spaced or to have been omitted, at least at these locations. Our reviews to date indicate that, at least, a level of column tie reinforcement consistent with the 1967 design of the hospital had been intended. The portico could be considered something of a soft-story condition, as the levels above it had significant infill masonry.

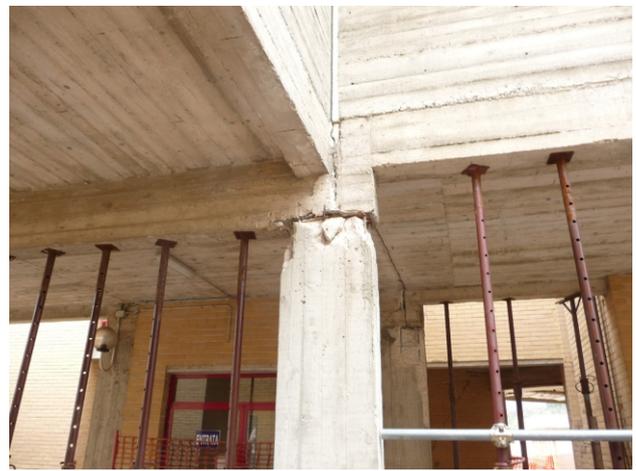
Finally, poor structural detailing of certain seismic joints led to local damage at one column supporting the elevated corridor structure that connects the buildings on the hospital campus. Frequently, seismic separations were not

achieved by bringing separate but adjacent vertical members up from a common footing, but rather, by having adjacent upper-level portions of the building supported on a common wall or a common column. In the case of one narrow column this caused local damage to the column and a loss of bearing.

Fig. 11 Damage to a separation joint that occurred over a shared column.

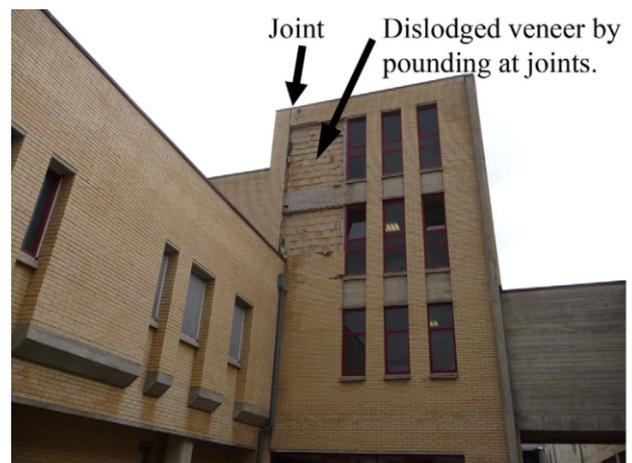
It was generally observed that from a seismic engineering point of view, the joints between adjacent buildings and structural units were poorly detailed and constructed. Some joints were likely intended to only be expansion/contraction joints, and even as such could have been better configured. Because of this style of detailing, and because the joint width (capacity) of the exterior brick veneer and the interior hollow clay tile infill and plaster was generally less than that between the concrete structural elements, there was localized damage to the exterior veneer and interior infill and plaster, including local collapse of some exterior veneer (Fig. 12).

Fig. 12 Veneer dislodged by pounding at joints.
