# EARTHQUAKE HAZARD CENTRE NEWSLETTER

Vol.6 No.4

APRIL 2003

## Summary of “Preliminary Observations on the October 31–November 1, 2002 Molise, Italy, Earthquake Sequence.”

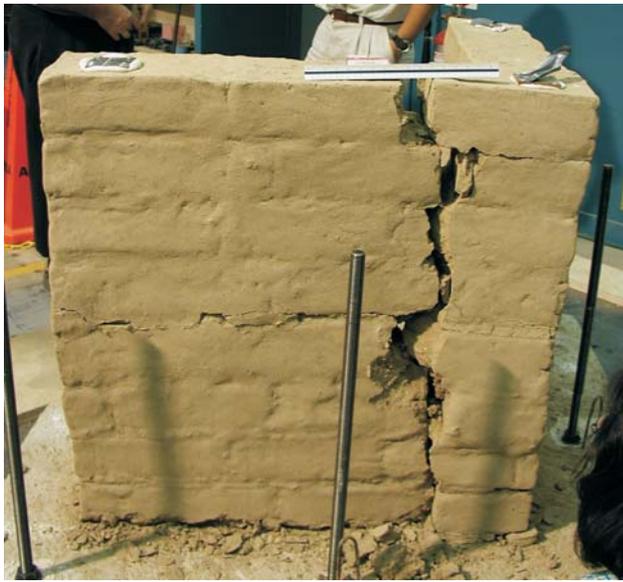
Severe structural damage of a 'traditional' element (Fig. 2) occurred at 65% of the intensity of the January 13, 2001 event. The major failure of the specimen occurred at the intersection of the walls, with the cracking essentially creating two distinct walls. The damage was consistent with MSK scale VII (Damage of Buildings) or VIII (Destruction of Buildings) type earthquakes.

Fig. 2 'Traditional' element damage

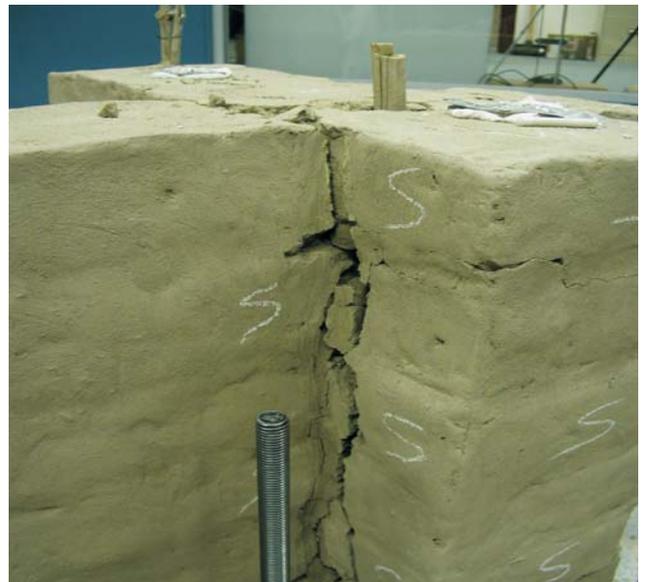
The improved element exhibited significantly better structural stability. The major threat comes from the high probability that the 'wedge' in the buttress will separate from the corner if a further force is applied. This represents an acceptable level of risk because the 'wedge' is on the outside of the building, and is relatively small. Some form of barrier should be erected around this area to prevent injury. Although the main structure was significantly damaged it is still relatively stable and the risk of wall collapse is greatly reduced.

Fig. 4 'Improved' element damage

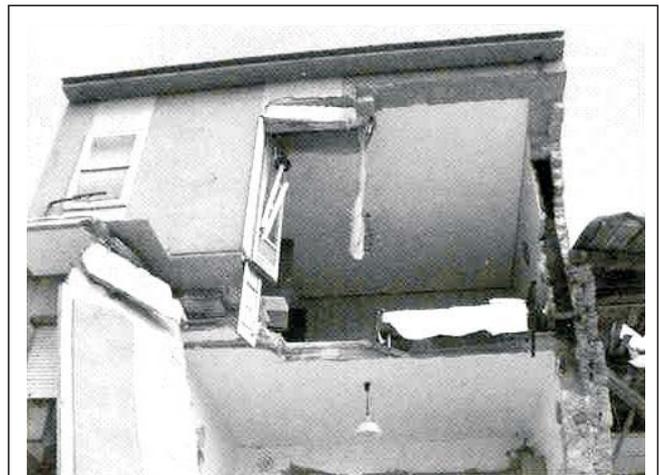
*Fig. 7 San Giuliano. Failure of the exterior wall not properly connected to the slab*

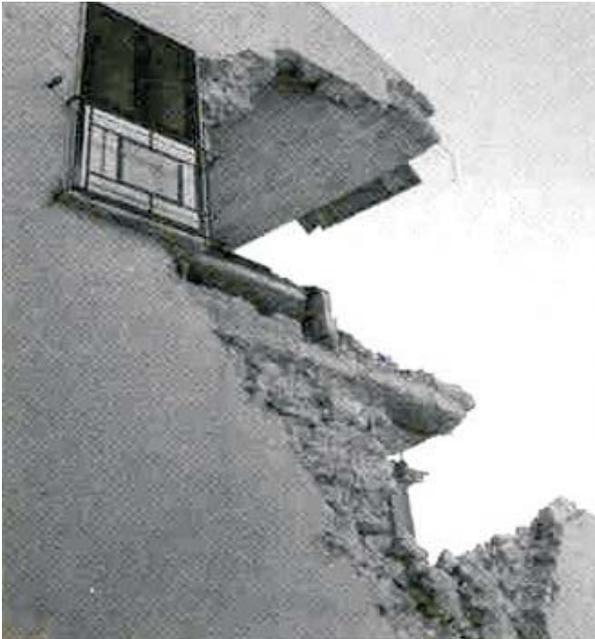
*Fig. 8 San Giuliano. Degraded mortar and poor construction material in foreground wall.*

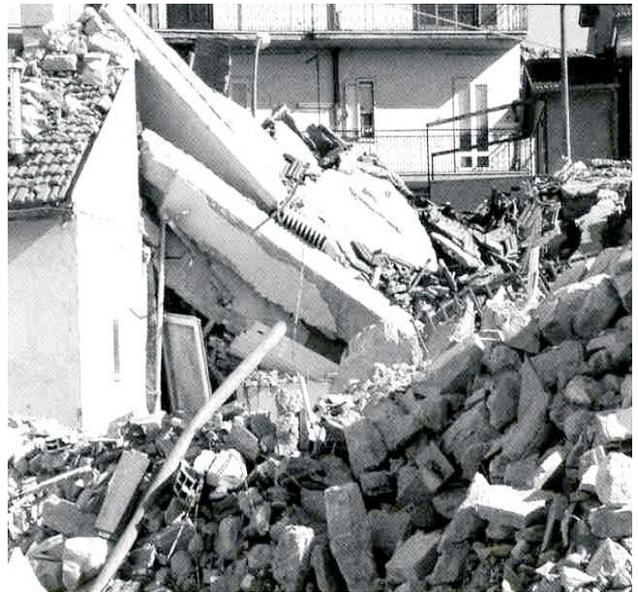
*Fig. 10 Collapsed school in San Giuliano di Puglia. Note the very heavy slab of the second storey and the roof that was supported by a first storey bearing wall of poor-quality stone, now collapsed.*

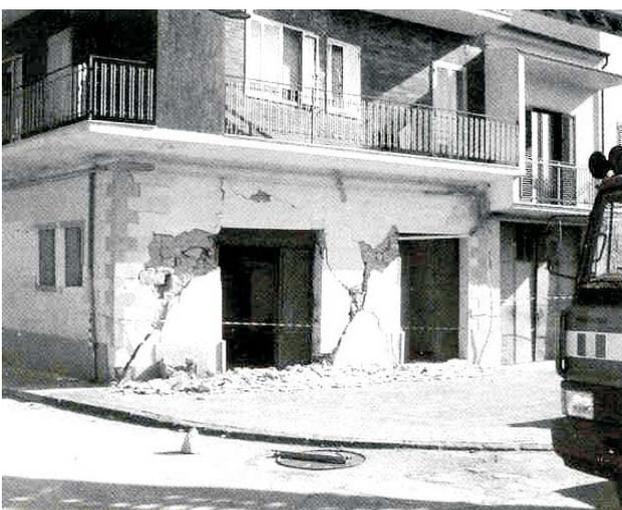
*Fig. 9 San Giuliano. Large diagonal shear cracks in the proximity of the large openings. The two storeys above built more recently in reinforced concrete and hollow-brick infills are unscathed. The bottom storey essentially acted as a base-isolation system. The building is going to be demolished.*

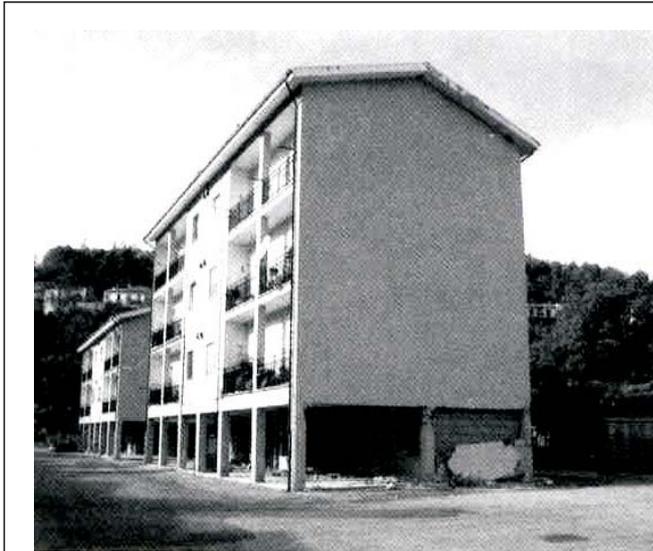
Two buildings of particular interest were a pair of concrete frame residential apartment structures located in Bonefro (Figs. 11 and 12). The two buildings, constructed in 1984, were founded in a valley, at the base of the historic portion of the town. Both structures were identical in plan and structural composition, but vary in height, one with three storeys and the other with four. The four-storey structure suffered substantial structural damage at the ground level, focused mainly along the east elevation. The three-storey structure suffered no structural damage and only minor cracking in the exterior plaster finishes.

The damage to the four-storey structure is likely due to the additional mass of the fourth floor level.

*Fig.11 Two concrete frame apartment buildings in Bonafra. Construction of each building was identical, with the exception of the additional floor. The four-storey building sustained major damage in the two events, resulting in a major collapse hazard.*

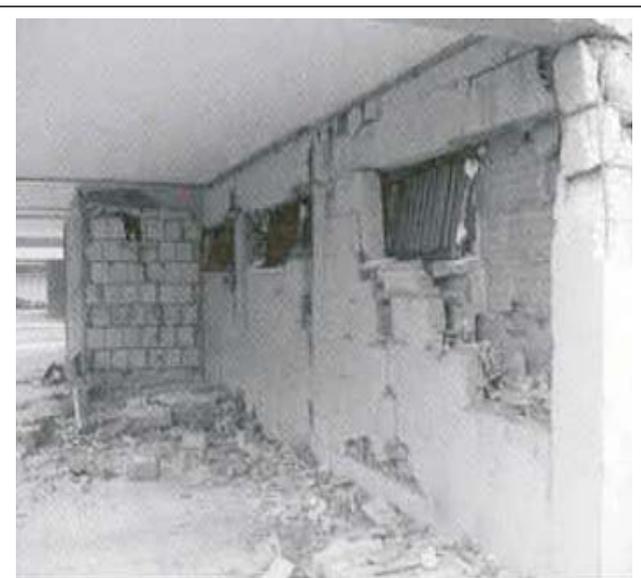
*Fig. 12 Interior of concrete frame apartment building in Bonafra. Extensive damage at the ground level of the four-storey building after the aftershock of November 1.*
