EARTHQUAKE HAZARD CENTRE NEWSLETTER

Vol.16 No.1

JULY 2012

Virtual Site Visit No. 29: Reinforced masonry construction

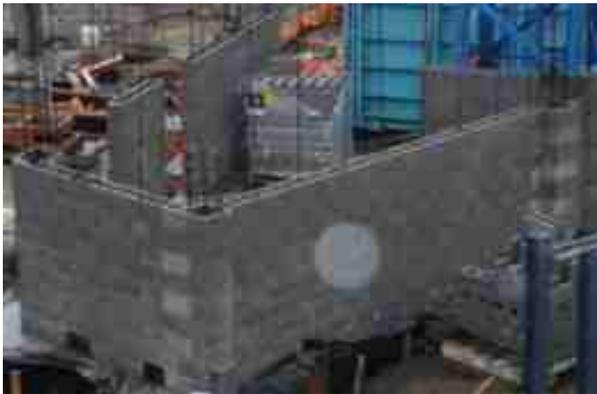
The masonry units for the ground floor walls of the core have been laid and soon they will be filled with grout. Vertical bars can be seen projecting from above the top course of the masonry units, which conceal the closely-spaced horizontal bars that are necessary to withstand horizontal shear forces.

Fig. 1 Unreinforced masonry walls for the building core.

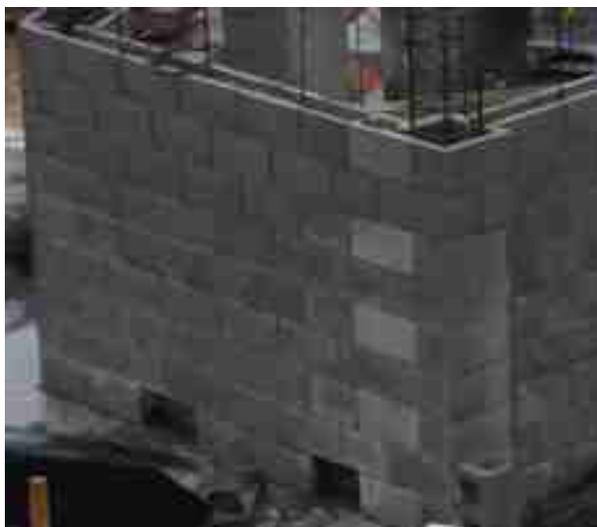
Figure 2 shows a crucially important construction detail – clean-out ports along the bottom course of masonry units. These ports are provided every third unit to enable reinforcing bars to be tied to the starters projecting from the foundation footings, and just as importantly, to enable the horizontal construction joint between footing and wall to be properly cleaned. During the block laying process, mortar is accidentally dropped down the blockwork cavity.

Fig. 2 Clean-out ports at the wall base to allow the construction joint to be properly cleaned and inspected prior to grouting.

In order for the grout to bond with the footing concrete, not only does that concrete surface need to be intentionally roughened, but it must be washed or even brushed clean of mortar droppings. Only after a quality control inspection has been satisfied that the joint is clean, should the clean-out port walls be reinstated and the wall grouted.

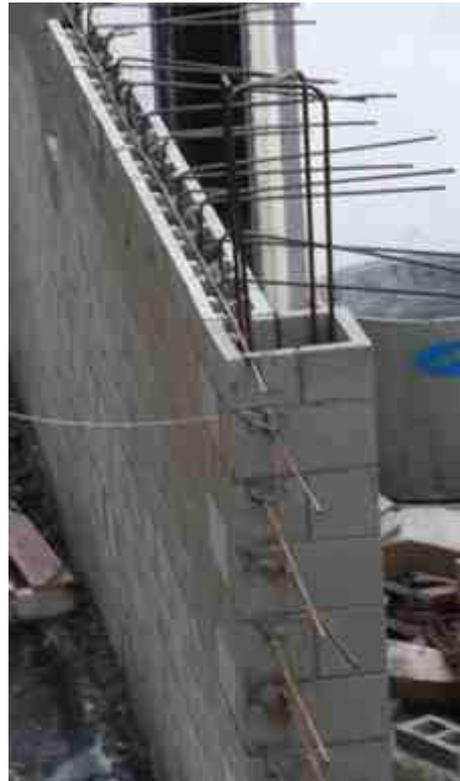
Fig. 3

The rear reinforced masonry retaining wall is shown in Figure 3. Various reinforcing bars are visible. First, one can see the vertical bars which have been bent over to be cast into the floor diaphragm. These bars will enable horizontal seismic shear forces from the diaphragm to be transferred into the shear wall. Secondly, horizontal shear reinforcement protrudes from this section of wall which is detailed to form a vertical crack control joint. These bars will lap with horizontal bars in the next section of wall to ensure adequate wall shear strength in the event of an earthquake. The attached pier has yet to have horizontal ties to confine its vertical reinforcement, and then, after grouting it will be able to receive the end of a horizontal beam and the gravity loads it will transfer.

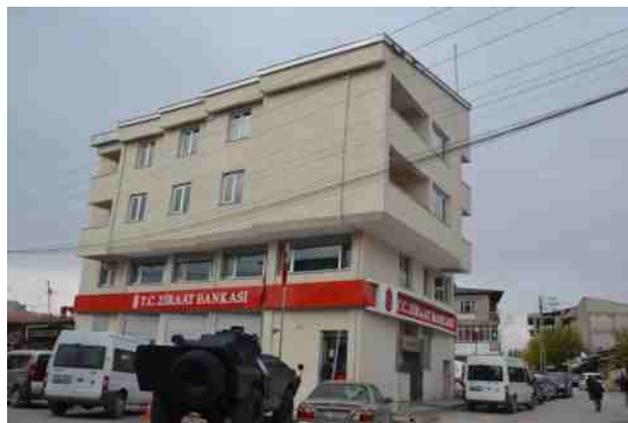
There were several seismically strengthened buildings in the area, three of which were visited by team members. The Ziraat Bank building in Erciş survived the earthquake with minor damage (Figure 4). The Kazım Karabekir Primary School in Erciş is a four-story reinforced concrete frame/structural wall building with hollow clay tile walls used as partitions; it had been retrofitted by replacing some of the hollow clay tile infill walls with reinforced concrete structural walls. A survey of the structure revealed that the material quality and the reinforcement detailing in the original framing was inferior. During the October earthquake, there was widespread partition wall damage in the structure. Beams supporting the stairs exhibited damage as well, but it was due to discontinuity in the flexural reinforcement. The existing (original) structural walls of the structure in the N-S direction had a diagonal web of hairline cracks up to the third story. There was separation at the interface between the added structural walls and the perimeter framing, particularly the beam to which the added structural reinforcement was anchored. The damage pattern indicates that the added shear walls did not engage with the existing structural frame right away.

Fig. 4 Local branch of Ziraat Bank which was seismically strengthened before the recent earthquakes (photo: Alaluf).

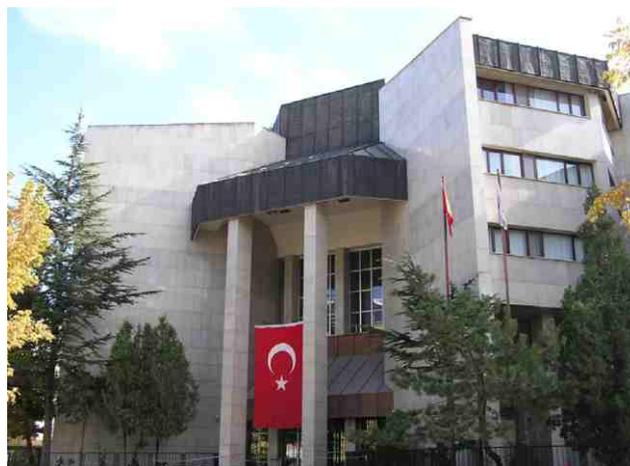
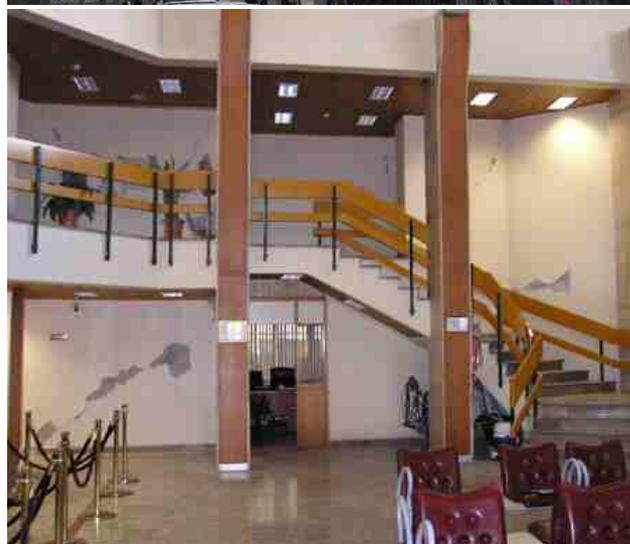
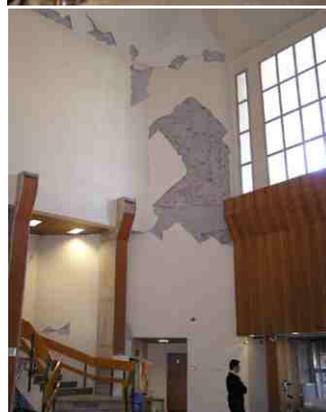
Reportedly, the Van branch building of the Turkish Central Bank had been reviewed for possible seismic strengthening, but that had been deemed unnecessary (Figure 5). This very irregular five-story building has a three-story atrium and wing walls at the perimeter as the primary structural elements of the system. No structural failure was seen in the system except for a crack on one of the beams; however, extensive partition wall failure in the building disrupted services.

Fig. 5 The Van branch building of the Turkish Central Bank (photos: Dönmez).

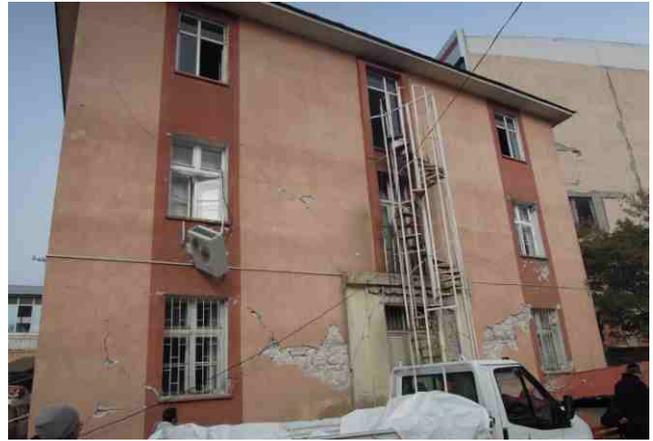
Structural systems in government buildings varied depending on the age of the structure. The spectrum stretches from stone bearing-wall systems in old structures to RC frames in relatively new structures, but RC frames predominate. They are subject to special regulations depending on the ministry with which they are associated. The Erciş Palace of Justice is an example of the old bearing-wall systems. As shown in Figure 6, cracks formed in the walls and went through concrete lintels within the walls.

Fig. 6 Severe damage to walls of Erciş Palace of Justice (photos: METU group).

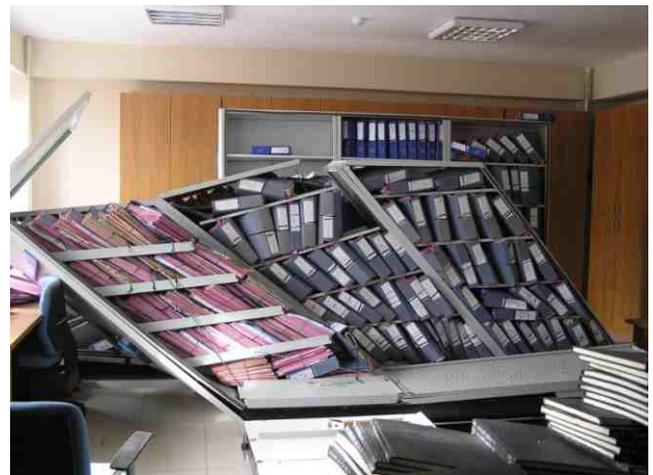
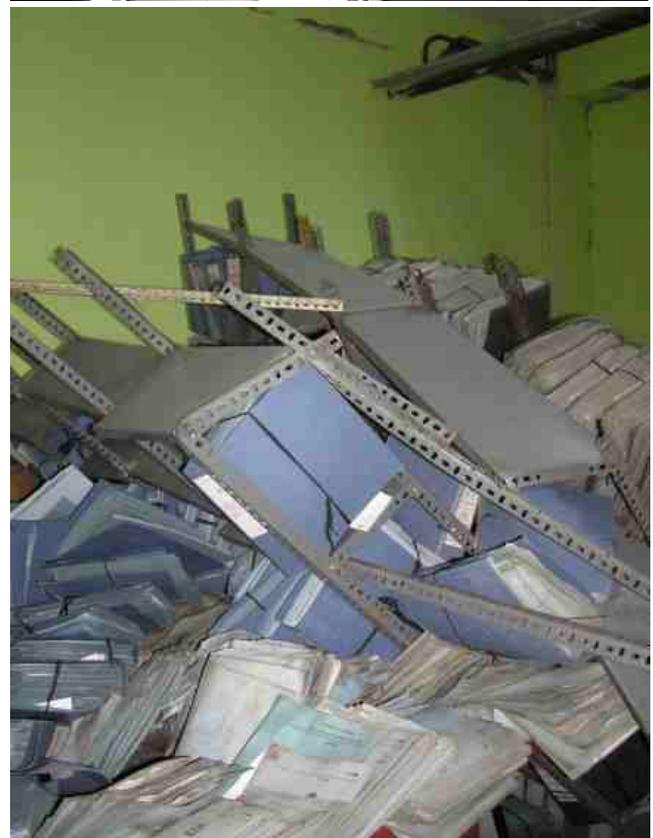
The Erciş District Governor's Office, a campus of two- to five-story plus basement modern RC buildings with frame and structural wall systems, sustained no structural damage and only minor damage in nonstructural walls. The main problems were failed water tanks in the basement, collapsed archive support systems (Figure 7), and ceiling tile failure in the conference hall on the top floor.

Fig. 7 Archives in Erciş District Governor's Office (photos: İrfanoğlu).

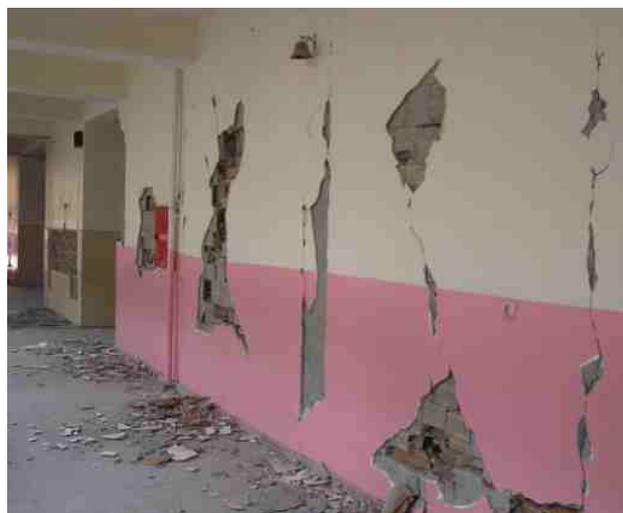
Primary schools inspected in both Van and Erciş had in-plane and out-of-plane damage to the hollow clay tile infill walls and minor structural damage in some of them. Many schools had cracking at the frame/wall interface, diagonal cracks, through-cracks, and crushing of the infill walls. Out-of-plane gable wall failure was typical in all of the schools that were observed throughout the area. At the Cumhuriyet Primary School (Figure 8), a conglomeration of four-story buildings located approximately 0.5 km southeast of the collapsed building ("Sevgi Apartmanı") that claimed 50 lives in the city center of Erciş, there was only minor damage to the structural system. Except for a corridor in which the infill walls were crushed, minor to moderate damage to the infill walls with cracking at the wall/ frame interface, was observed.

Fig. 8 Cusbed infill walls in Cumburiyet Primary School in Erciş (photo: İrfanoğlu).

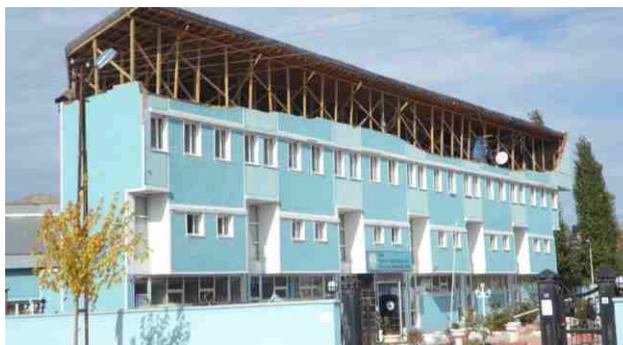
Near the Van pier, a three-story building used as a teachers' residence had out-of-plane wall failure. Above the third-floor ceiling slab, the structure consisted of wood post/beam framing supporting the roof with a story height equivalent to the floors below. The wood-framed portion had wood diagonals placed systematically to provide stability. On two sides of the structure at the uppermost story, out-of-plane wall failure was observed (Figure 9).

Fig. 9 Teachers' housing in Van near the pier (photo: Hernandez).

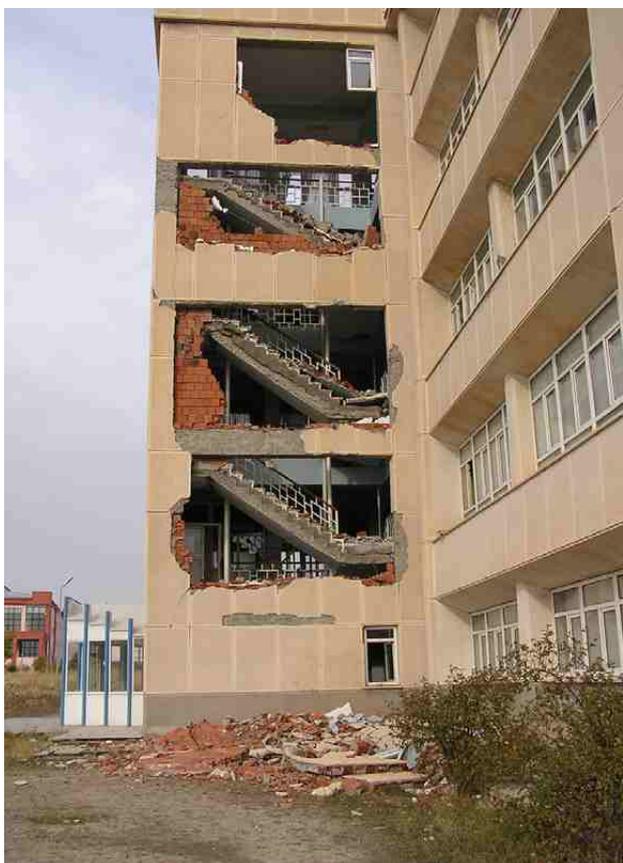
Overall, campus buildings performed well from a structural point of view, with most buildings having only minor to moderate damage to the hollow clay tile infill walls. The library, a five-story building with an irregular footprint and obvious inferior concrete quality and reinforcement detailing, sustained the most damage and is currently out of commission. The damage appeared to consist primarily of an out-of-plane collapse at a gable wall and the exterior wall at the exit stair well, heavy structural damage at the stairs and some beams in the structure (Figure 10).

Fig. 10 Library building at Van Yüzüncü Yıl University (photos: Dönmez).

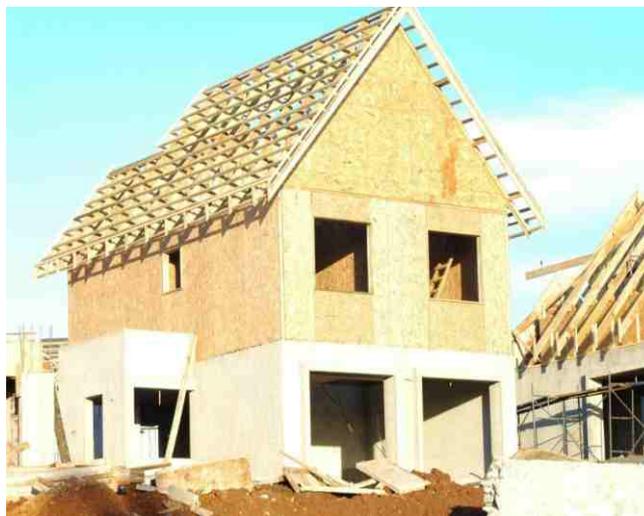
Fig. 11 Residential home in Concepción incorporating lower storey of reinforced masonry and upper storey of plywood and timber frame. (Photo: Hugh Cowan).

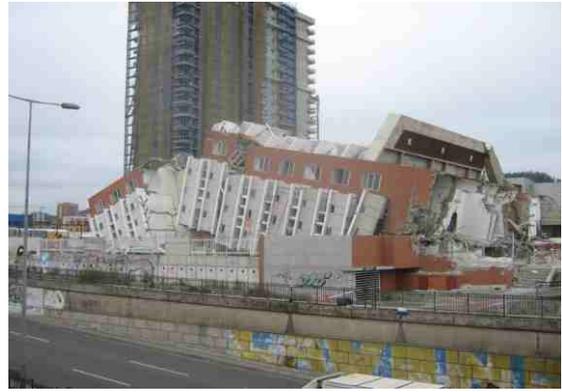
Fig. 12 Catastrophic failure of the multi-storey "Alto Rio" apartment block in Concepcion. (Photo: Hugh Cowan).

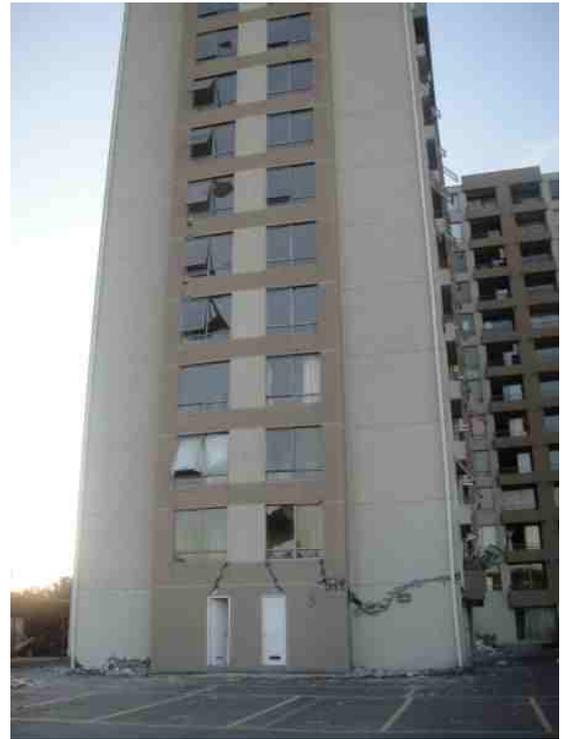
These walls typically failed in flexure with horizontal cracking below first floor level. The failure mechanism demonstrated the potential for buckling of the vertical reinforcement to cause spalling of the cover concrete. With the cover concrete spalled and the compression reinforcement ineffective due to buckling, there was a significant reduction in the area of concrete left to resist the compression load and the concrete core remaining being unconfined, resulted in progressive failure of the remaining concrete core resulted in a vertical failure of the wall. Where the outer edge of transverse walls were supported on lightly reinforced columns, the significant load induced under overturning of the shear wall above resulted in column failure.

Fig. 13 Shear wall failure, Plaza del Rio, Concepcion. (Photo: Peter Smith).

The need for shear walls to be detailed to prevent buckling of tension and compression reinforcement in areas where inelastic deformations are expected and to confine the core concrete that must provide an essential part of the compression resisting structure was amply demonstrated in the structural failures in Chile.
