# EARTHQUAKE HAZARD CENTRE

## NEWSLETTER

JANUARY 2009

## Virtual Site Visit No. 15: Medium-rise commercial reinforced concrete shear wall building, Wellington, New Zealand

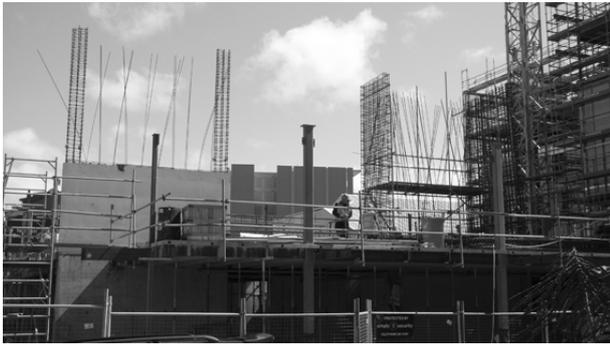
*Fig. 1 A general view of the building site showing some of the reinforced concrete shear walls.*

Reinforced concrete shear walls are designed to resist all the lateral seismic and wind forces acting on this building. Orientated along both orthogonal axes of the building plan, the shear walls will also resist any in-plan torsion rotations. Slender steel columns resist gravity forces. A general view of the building site (Fig. 1) shows some of the shear walls. Their layout separates some of the tenancies and does not disrupt architectural planning. Since the walls resist all horizontal forces, the gravity-only structure comprises shallow flooring elements and columns with relatively small cross-sectional dimensions.

This building is a good example of shear walls functioning as the sole seismic force resisting system. Any moment frame action from the gravity-only columns and beams will be so minimal compared to the strength and stiffness of the shear walls that it can be neglected.

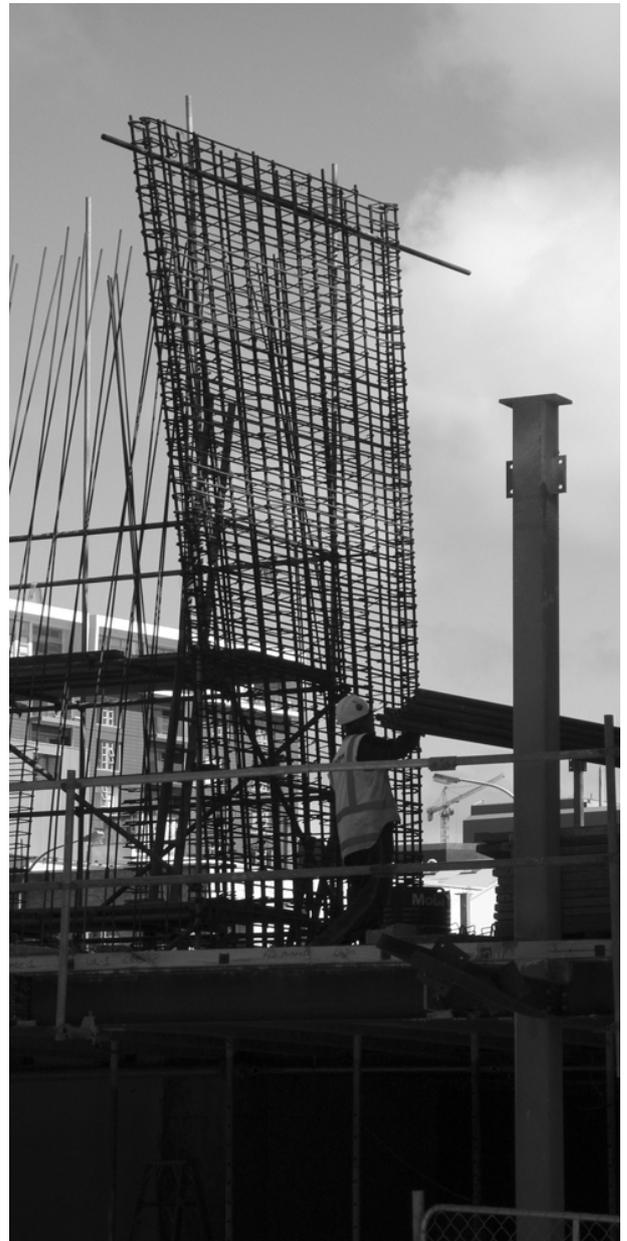
*Fig. 2 Shear wall reinforcing that consists of both vertical and horizontal bars.*

Figure 2 illustrates the internal reinforcing of a typical shear wall. Vertical bars provide bending resistance against horizontal forces that act on the wall from each floor diaphragm. Horizontal steel increases the shear capacity of a wall to such an extent that in a seismic overload situation a ductile flexural plastic hinge will form at the base of a wall before brittle diagonal tension shear failure occurs. Small additional horizontal ties are placed at the each end of a wall to confine the concrete in that area and thereby increase the wall ductility. These ties are seen more clearly in Figure 3.

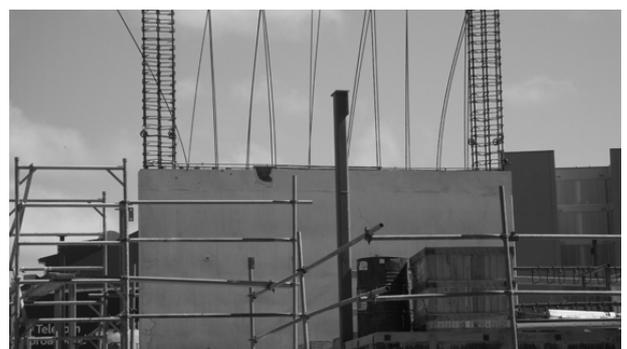
*Fig. 3 The confined end zones of a partially cast wall.*

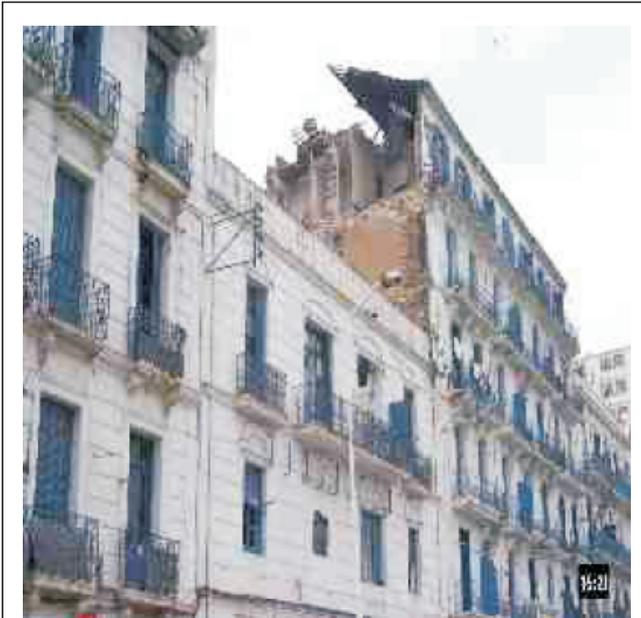
Fig. 6 Examples of old colonial masonry buildings.

Around this urban nuclei, old colonial constructions were built (Fig. 6) dating from the 19<sup>th</sup> century and the beginning of the 20<sup>th</sup> century. The buildings consist of several storeys (up to 12), generally not horizontally and vertically tied.

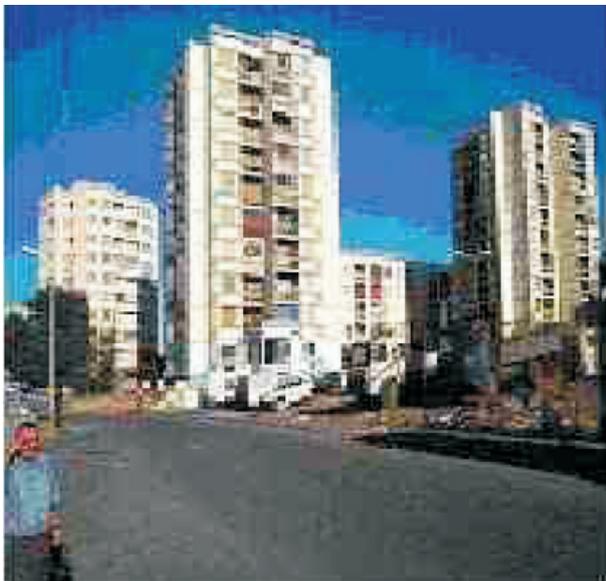
Fig. 7 New reinforced concrete building in the Bab-Ezzouar district.

The most recent constructions are buildings ranging from five to nine storeys designed according to the seismic code. The quality of construction is however neither always satisfactory, nor uniform. 22 000 of these residences (Fig. 7), were built in the suburbs of the city.
