EARTHQUAKE HAZARD CENTRE

NEWSLETTER

Vol.12 No.4

APRIL 2009

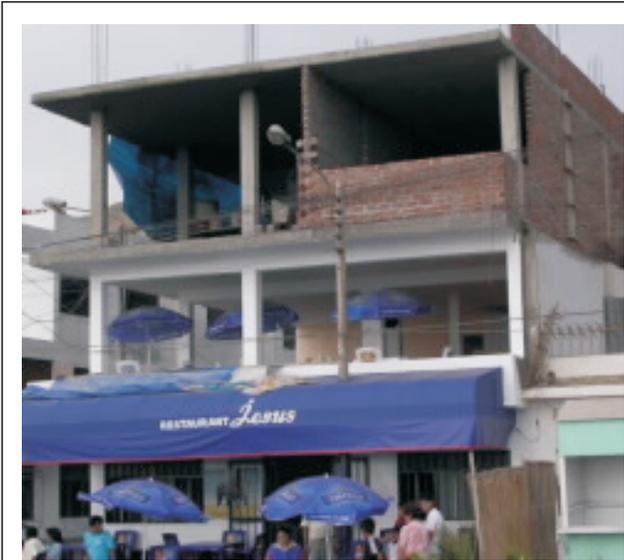
Fig. 1 The partial-height front wall and the interior brick partitions are vulnerable to face-load collapse.

In this Site Visit, we observe three multi-storey buildings under construction in Peru (Figs. 1 – 3). We focus not upon structural elements, but upon the unreinforced masonry cladding and partition walls.

Partial-height walls are also vulnerable. Unless they have vertical reinforcing steel within them, they can't act as vertical cantilevers and are therefore at risk of toppling.

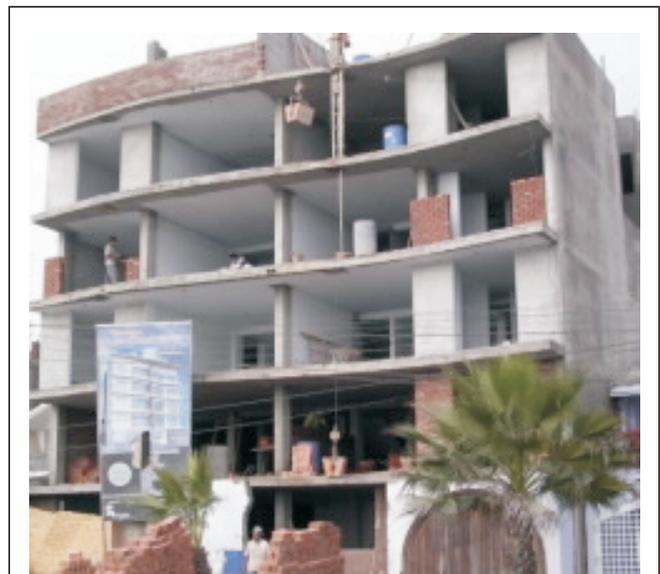
Fig. 2 Free-standing walls are likely to topple under horizontal inertia face-loads.

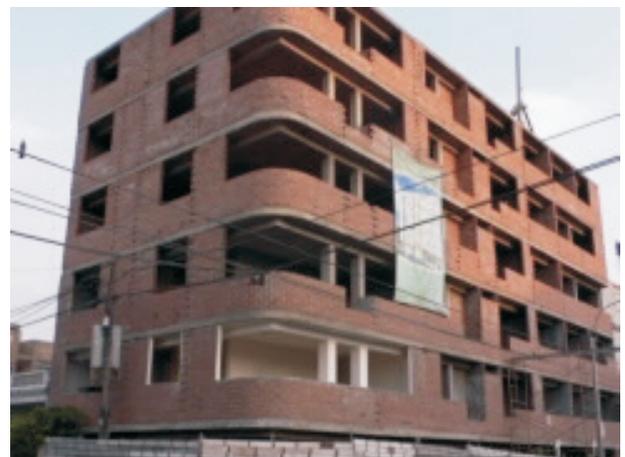
Fig. 3 If these unreinforced brick cladding walls are not restrained by steel detailing, they are potentially dangerous.

Due to both of these effects, relative displacement and horizontal accelerations, it is likely that severe damage could occur to the unreinforced masonry walls. Unless they are reinforced and physically connected to floor structures above with some sort of steel reinforcing, they

will probably collapse, falling into and out of the building. Such unreinforced walls represent a considerable hazard to those within and outside the building.

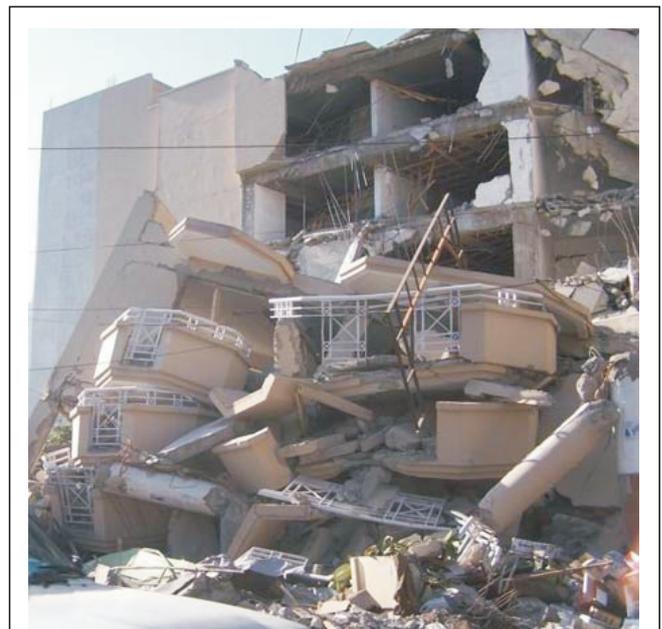
Fig. 4 Poor structural performance of MICF Buildings during an earthquake.

The structural system proposed by the local firms for these two buildings was the same system typically used in building construction in Pakistan, i.e. masonry infilled concrete frames (MICF). A number of the common deficiencies found in such typical systems were evident in early versions of the structural drawings for these projects, such as frame members not properly detailed for ductile behavior, masonry infill walls not reinforced for out-of-plane loading, infill walls not isolated from the adjoining concrete frames, roof/floor diaphragms not properly connected to the lateral system, inadequate layout of footings etc. Furthermore, the design was based on inappropriate seismic design criteria. The design oversight office called for a comprehensive structural redesign of these projects based on a proper and rational structural design approach as outlined below, in accordance with the CEILA formulated basic seismic design criteria and approach mentioned above. It is important to note that this type of flawed structural system (MICF) is quite common, not just in this part of the world but also in quite a few other countries around the globe (Figure 4).

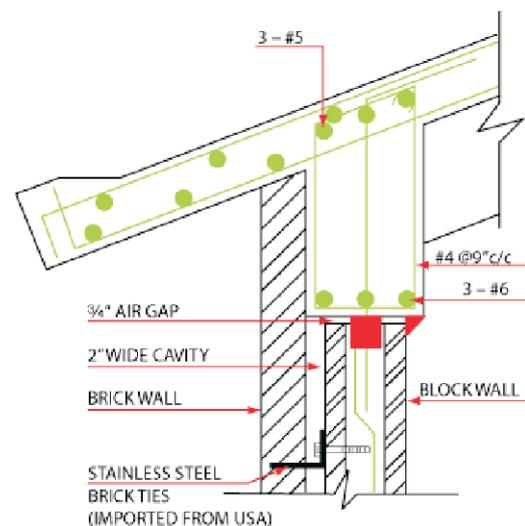
Fig. 6. CMU/ Brick veneer connection detail.

Concrete Masonry Unit (CMU) block walls have been used for partitions and exterior walls for these projects. These blocks are locally manufactured (per ASTM C90) and are readily available in the market. The block walls are isolated at the top to allow for the in-plane movement of the diaphragm, but anchored and properly reinforced for out-of-plane loading as shown in Figure 6, so the walls do not collapse and injure or kill occupants or pedestrians during an earthquake.
