EARTHQUAKE HAZARD CENTRE

NEWSLETTER

Vol.13 No.1

JULY 2009

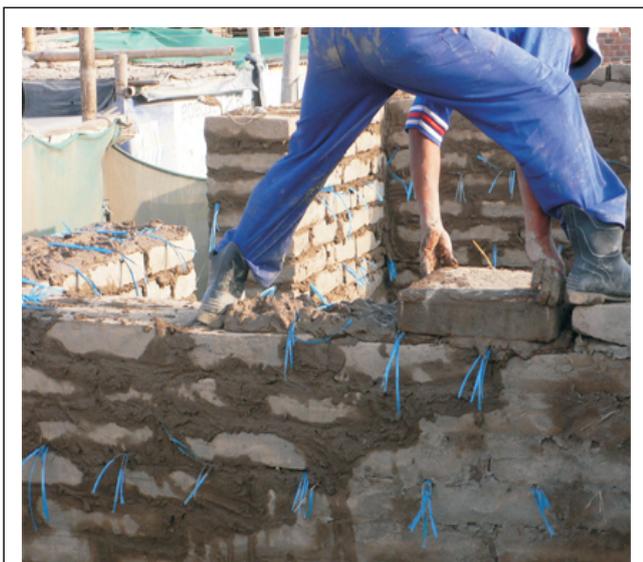
Fig. 1 Laying the adobe blocks with string ties placed in the mud mortar joints.

During the casting of the concrete foundation plinth above a stone and mortar footing, plastic geomesh is embedded so that it can be wrapped up each side of every wall. The adobe blocks consisting of their best-practice mixture of clay, sand, straw and water are then laid. For these houses the adobe block widths and lengths have been increased to 400 mm so that face-laden walls spanning between internal return walls are sufficiently rigid. Every few block courses short lengths of plastic string are placed into the fresh horizontal mortar joints (Fig. 1). When the wall is complete, geomesh is lapped and tied at foundation level and brought up both wall faces and wrapped over the wall top timber bond beam or top plate. Each string tie is firmly knotted to the mesh layer on each side of the wall. Rafters and the roof are then placed and fixed (Fig. 2). Next, adobe blocks plug the gap between wall plate and the underside of the ceiling lining and the wall is mud plastered (Fig. 3). The smooth finished

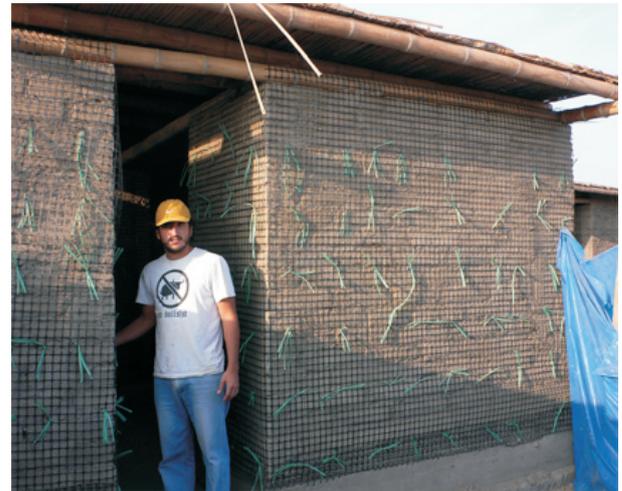
Fig. 2 Geomesh has been wrapped vertically and horizontally around walls.

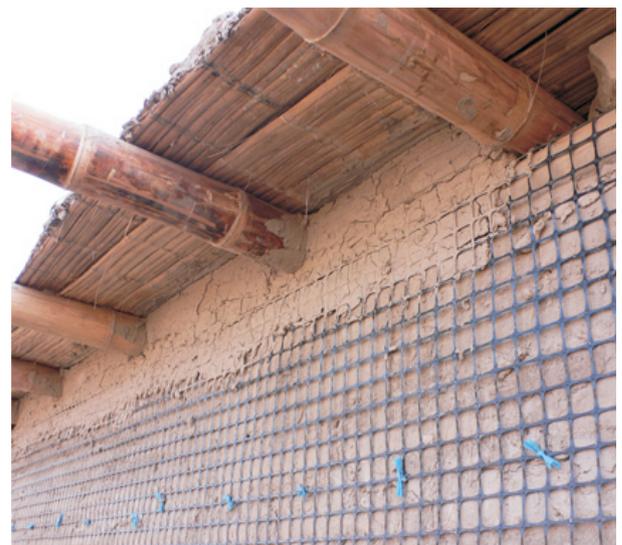
Fig. 3 Plastering of the walls is about to commence.

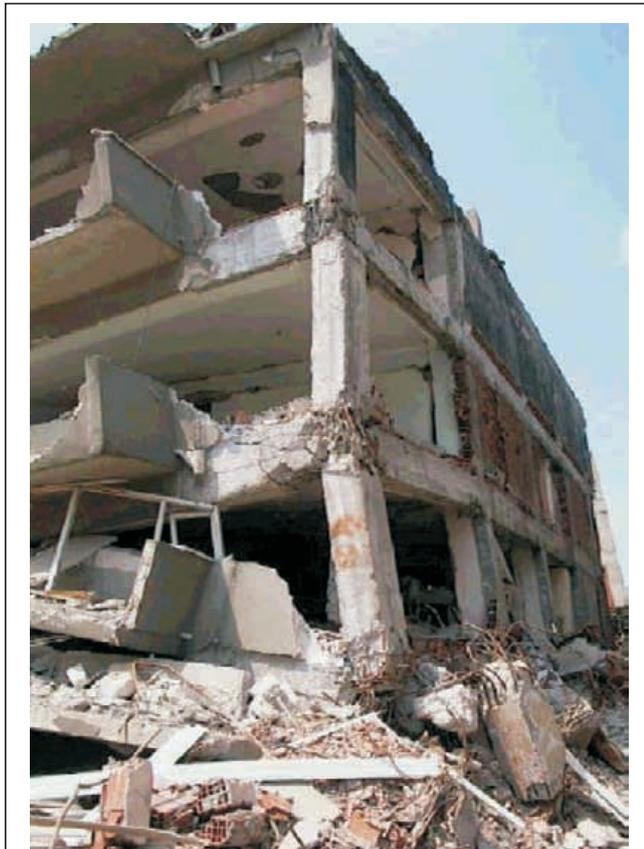
Fig. 4 Typical failure of poorly detailed reinforced-concrete frame buildings.

Moment-resisting RC frame buildings, without walls and braces, have shown a consistently high failure rate in urban areas with severe earthquake damage (Fig. 4). Lessons learned from such failures have motivated a series of changes in design standards. In general, design requirements have become more stringent, not only in terms of safety factors, but mainly with respect to detailing rules. The latter, unfortunately, have increased the structures' cost and decreased their constructibility. Although the cost of detailing may be a small fraction of the building cost, it is still useful to examine whether these costly and rather complex design changes have actually reduce the seismic vulnerability of frames and consequently, their damage intensity.

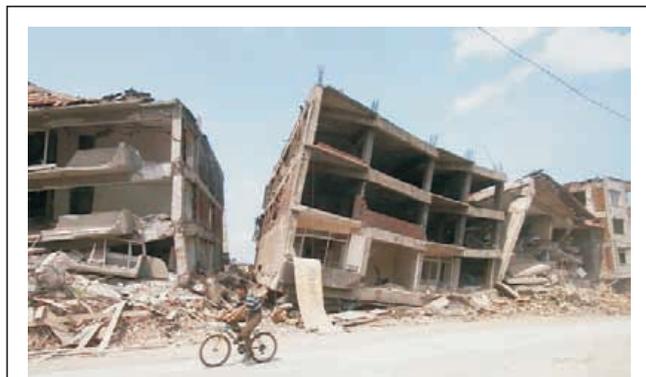
Fig. 6 Typical damage observed during 1999 Kocaeli earthquake in Turkey.

In Turkey, the most severe damage recorded after the 1999 earthquake was also concentrated in modern buildings (EERI 2000) (Fig. 6). Indeed, in recent years, Turkey's modernisation has led to rapid urban and industrial growth and to a change in housing patterns. Typical, small single-family homes of masonry or timber have been replaced by medium-rise structures, and in fewer cases, by high-rise buildings. These contemporary buildings consist of reinforced-concrete frames or, very often, of flat-slab systems, in which the beamless slabs are infilled with hollow clay blocks. The principal deficiencies of this category of buildings have been an inadequate structure configuration for seismic resistance (probably due to the absence of even a minimum seismic design) and the nonductile detailing of reinforcement. Construction errors and low-quality materials exacerbated the damage level. In general, it is fair to say that design and construction practices in Turkey were clearly inadequate for a zone subjected to a high seismic hazard. In several cases, designers and contractors from abroad, who were quite unaware of the local hazard and construction practice, carried out building design and construction. The latter observation also points out the need for a prior review and assimilation process of new building technologies and construction methods, which are seldom developed and applied for different hazard characteristics and for distinct design and construction conditions.

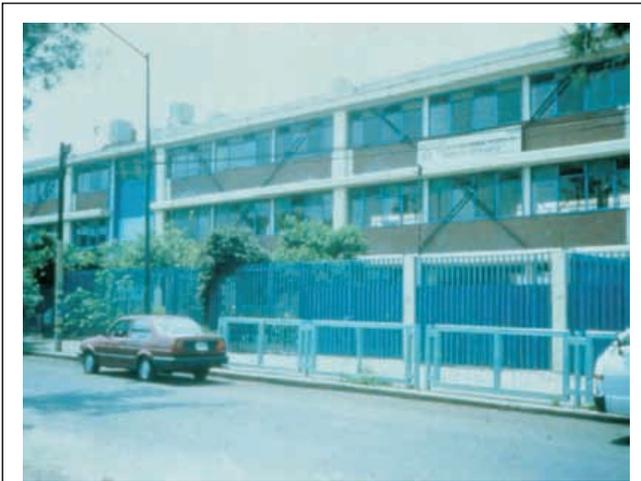
Fig. 10 Strengthening of school buildings by external post-tensioned cable bracing.

Regarding school rehabilitation, one success story deserves mentions. After the 1985 Mexico earthquake, more than 2,000 school buildings were rehabilitated, not only in Mexico City where damage has been severe, but also in other regions of significant seismic hazard. Rather simple and unobtrusive strengthening schemes were used, capable of being executed in a few months during summer vacations, to avoid interrupting educational activities. External strengthening elements were favoured to avoid disturbing internal finishes, furniture, or equipment. An example of the techniques used was external post-

tensioned diagonal bracing (Fig. 10).
