EARTHQUAKE HAZARD CENTRE

NEWSLETTER

Vol.13 No.2

OCTOBER 2009

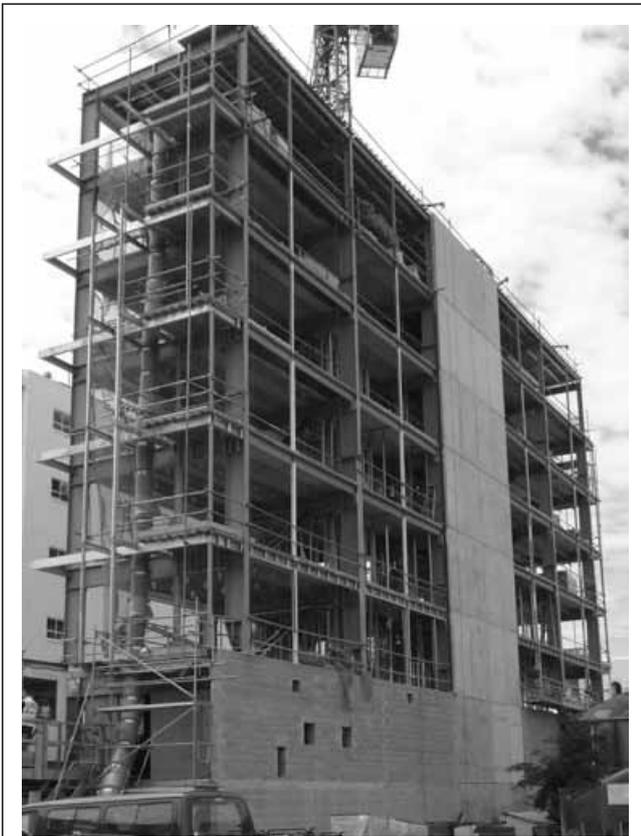
Fig. 1 The building under construction showing the one-bay steel moment frames and an RC shear wall.

In this eight-storey apartment building, steel framing supports all suspended floors and the roof, as well as resisting transverse wind and seismic forces. Longitudinal forces are resisted by shear walls that are constructed from strongly connected precast concrete panels on both sides of the building (Fig. 1).

In the longitudinal direction, three concrete shear walls provide resistance. The large wall (Fig. 1) is supplemented by two shorter walls on the other side of the building (Fig. 3). The walls are constructed from 175 mm thick precast panels joined along their vertical edges by plates welded to cast-in steelwork. Horizontal connections between the storey-high panels take the form of grouted-in deformed steel rods. The structural walls were also designed for elastic response resulting in the stiffest and strongest

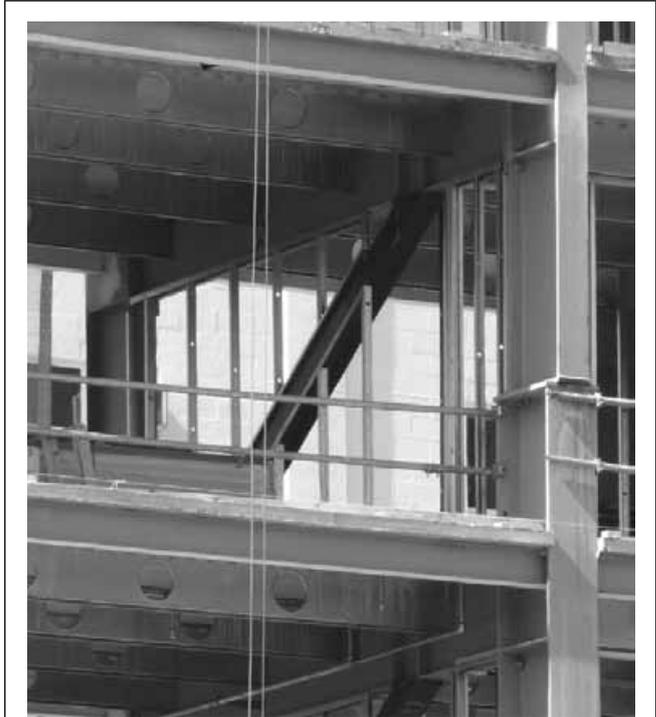
Fig. 2 One storey of an eccentrically braced frame.

Six steel moment frames are placed along the building length. They support floors and resist lateral forces. Near the middle of the building two of these frames are transformed into eccentrically braced frames by the addition of inclined struts (Fig. 2). While these are stiffer than the pure moment frames, under torsion effects the end moment frames resist similar amounts of force. Due to the narrowness of the site and the relative flexibility of the frames it was necessary to limit the amount of lateral drift. So they were designed for elastic rather than ductile response.

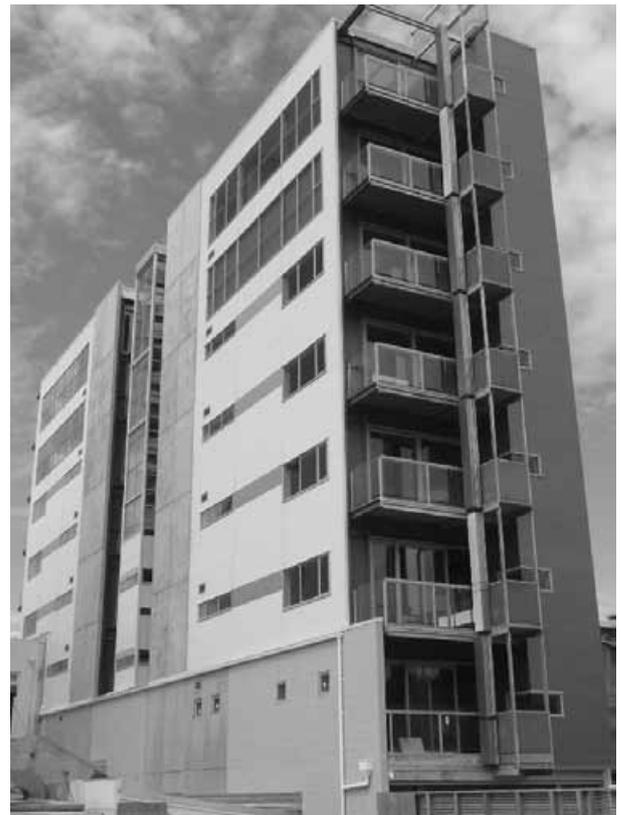
Fig. 3 The finished building with the two narrower shear walls.

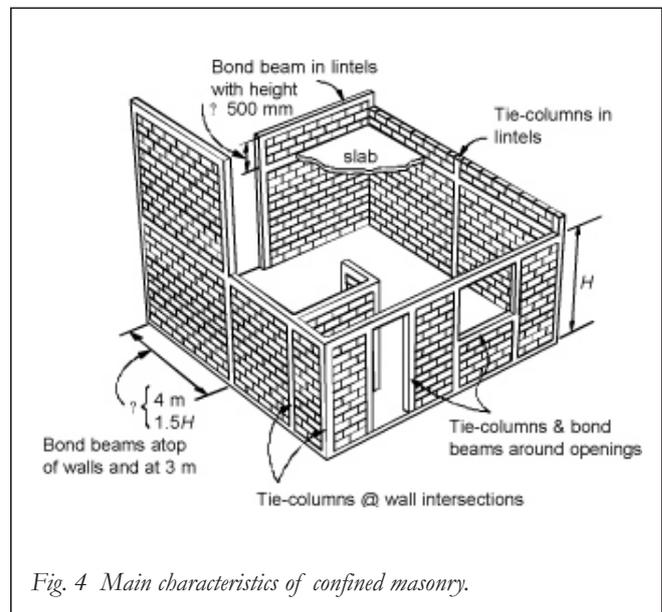
Fig. 4 Main characteristics of confined masonry.

The use of some type of reinforcement is probably the single most effective means of reducing earthquake damage of masonry construction. Confined masonry and reinforced masonry are prime examples (Figs. 4 and 5). Both types of masonry systems are commonly used in engineering construction of dwellings. Analysis, design, and construction methods and requirements are available for those systems, based on structural mechanics and experimental evidence. Confined masonry and

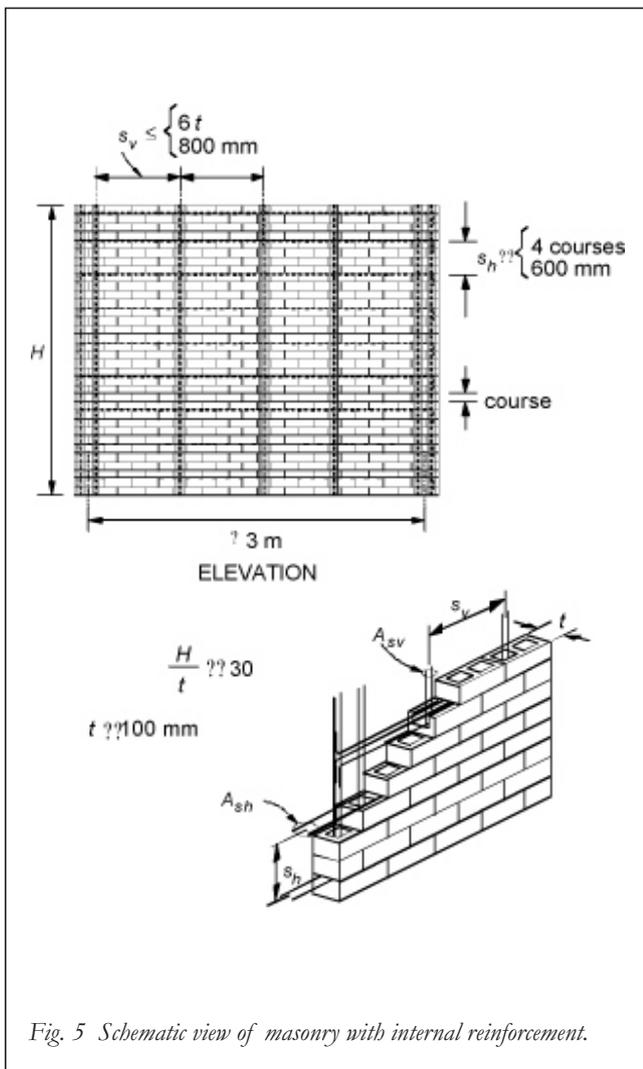
Fig. 5 Schematic view of masonry with internal reinforcement.

Unlike confined masonry, unreinforced masonry (Fig. 5) has been developed on an engineering basis, where quantitative design procedures (consistent with structural mechanics), as well as efficient and almost industrialized

construction processes have been followed. As in confined masonry construction, masonry's intrinsic weaknesses are addressed through the use of vertical and horizontal internal grouted reinforcement. Such bars additionally increase in-plane wall shear strength and deformation capacity, and help tie the transverse walls and floors together.

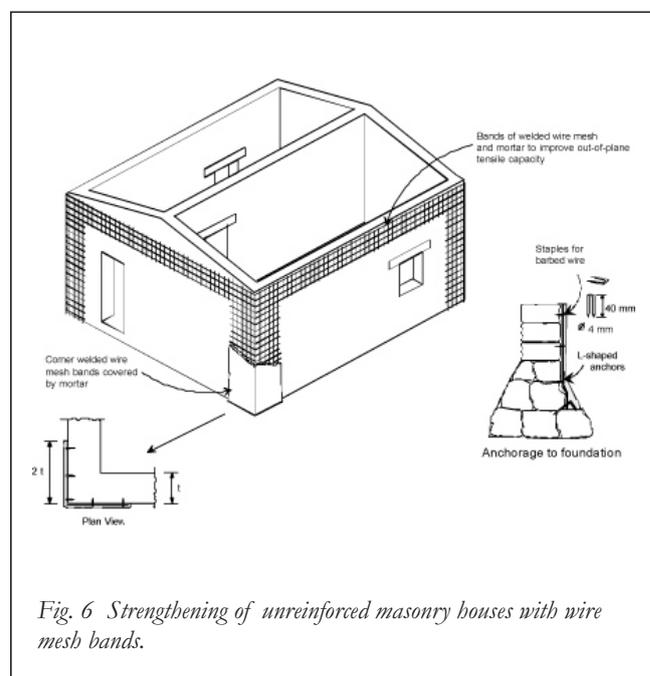
Fig. 6 Strengthening of unreinforced masonry houses with wire mesh bands.

All methods previously discussed for reinforcing masonry walls are applicable to new construction. However, many of them are also appropriate for building rehabilitation. Many efficient and inexpensive procedures have been developed for upgrading existing houses that either have been damaged by an earthquake or, as with most masonry construction, are clearly unsafe. Although these rehabilitative procedures vary in complexity and cost, most are based on improving the in-plane tensile strength of walls and on tying them together to avoid out-of-plane failure. One efficient and cost-effective technique is the addition of steel welded wire meshes, either completely jacketing the walls or placed along the wall edges in the form of bands (Klingner 2000) (Fig 6).

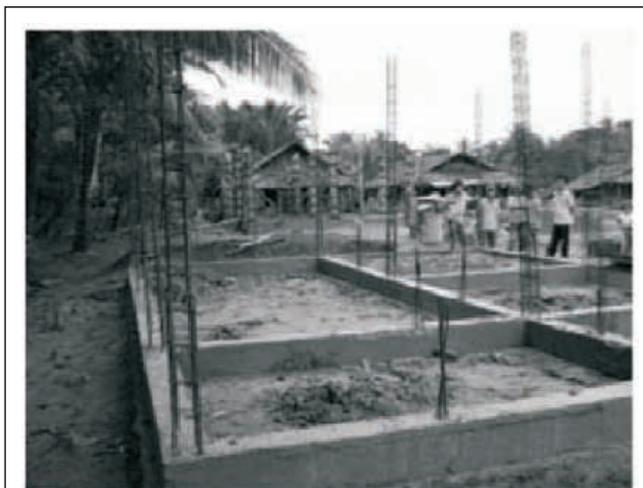
Fig. 7. Concrete foundations which have been well drained and well laid on sand using sufficient cement.

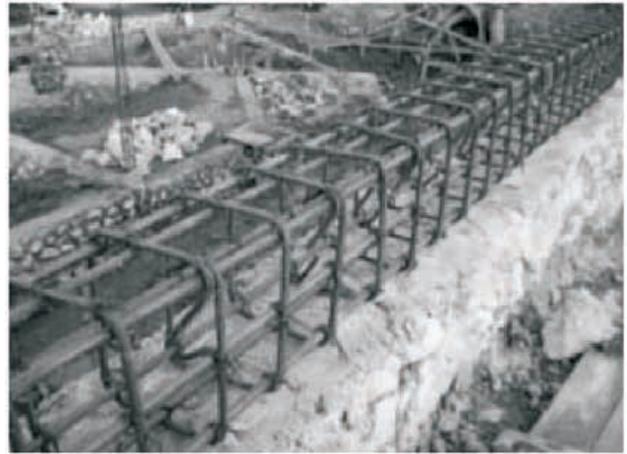
Fig. 8 Ends of steel reinforcing bent at 135 degrees for earthquake resistance.

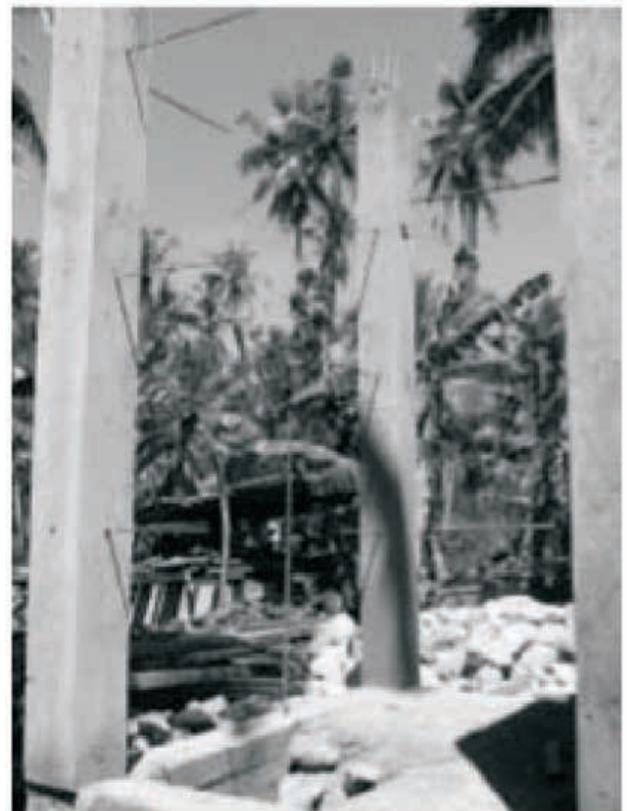
Fig. 9 A good example of wall ties which are inserted into columns before they were made.
