# EARTHQUAKE HAZARD CENTRE

## NEWSLETTER

JULY 2003

# Principles of Building Earthquake Resistance No. 25

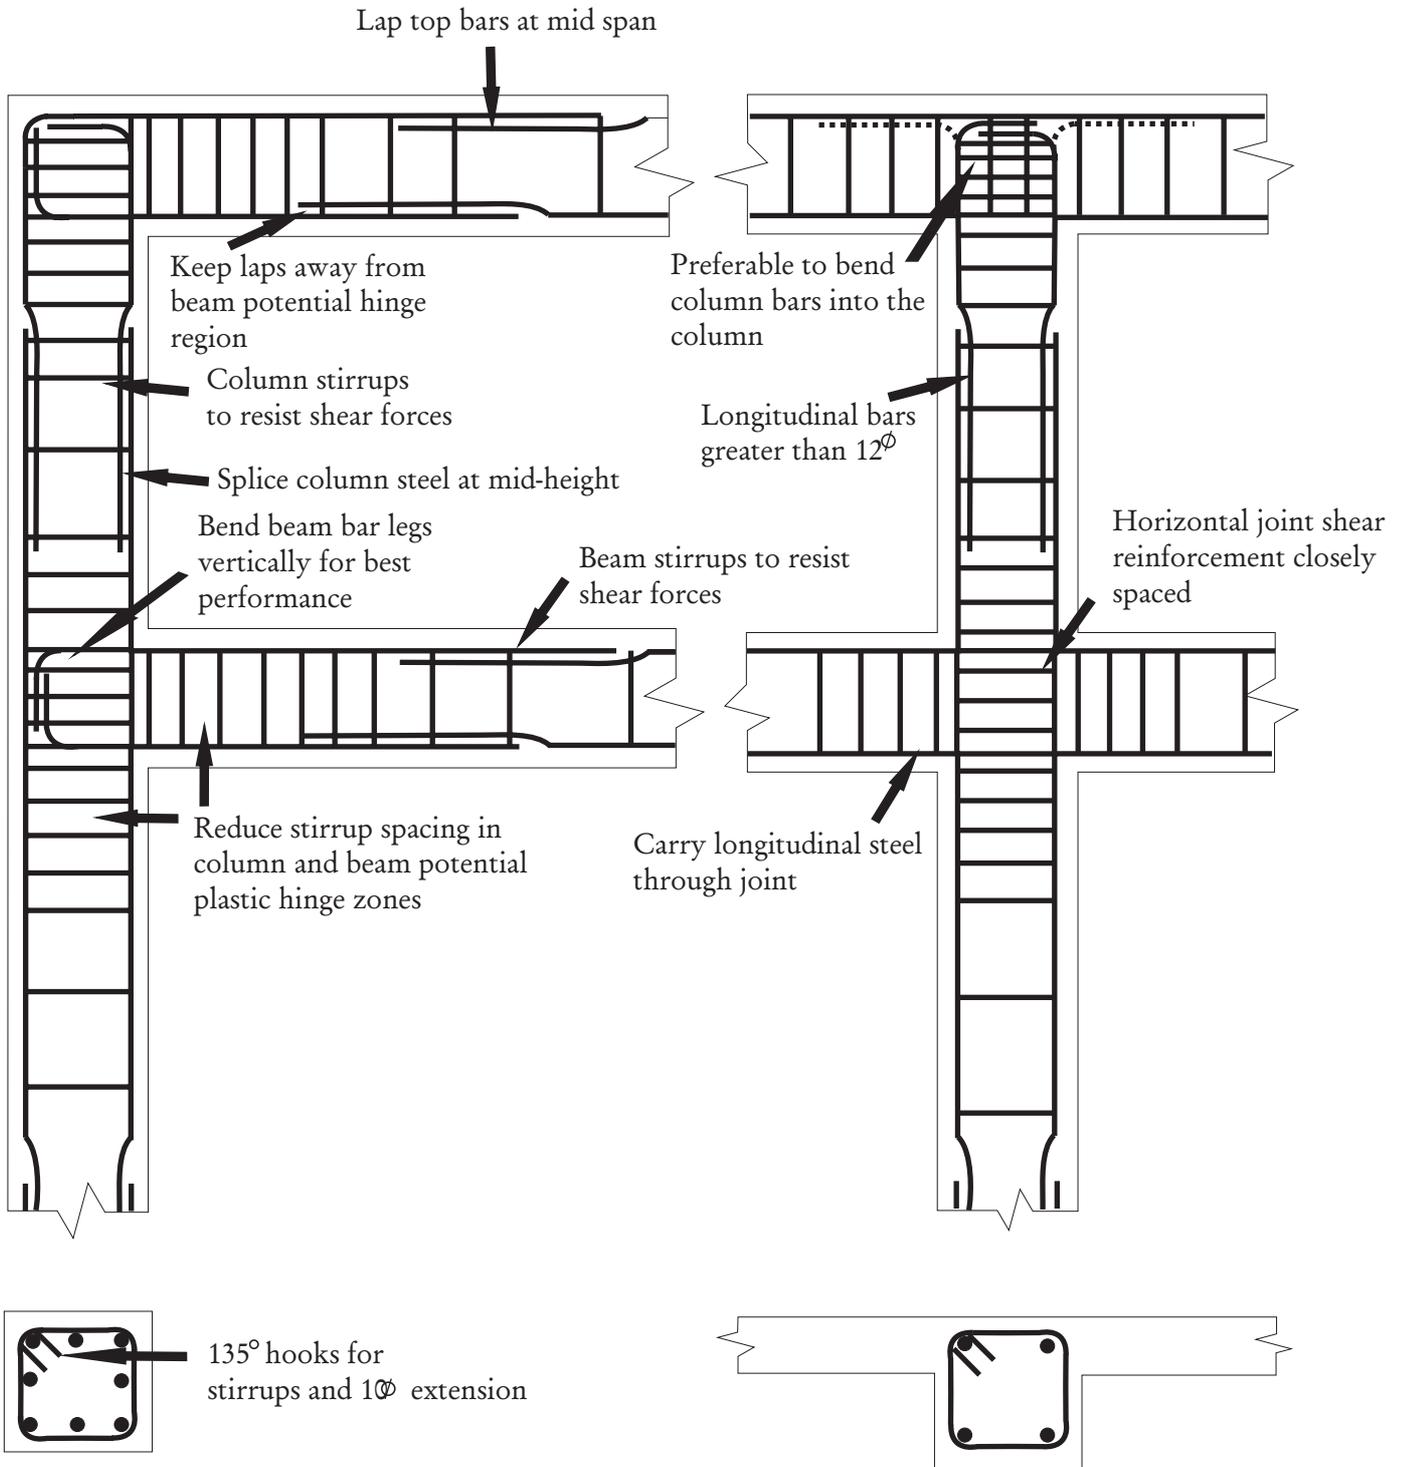
## An interior check-up of moment-resisting frames

In the last newsletter we looked at the relative dimensions of beams and columns that form effective seismic resisting frames. Now we focus upon the internal reinforcement that is necessary for reliable seismic resistance.

Typical column section

Typical beam section

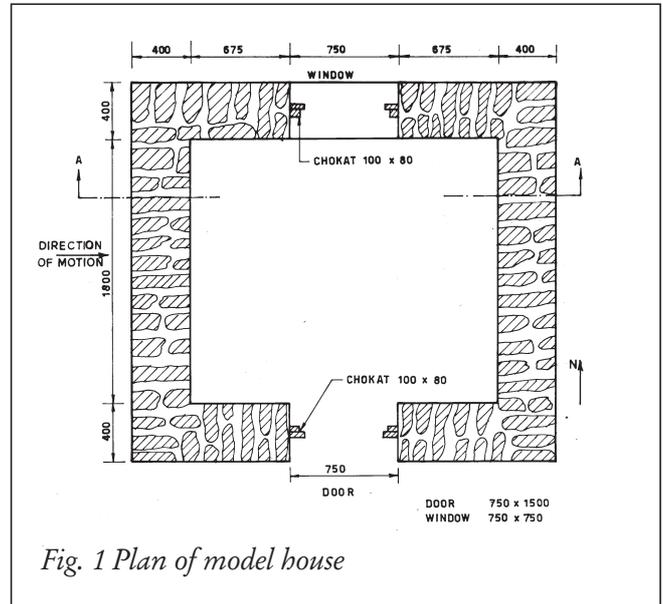
The model is single storeyed one room house measuring 2900x2600x2700mm and thickness of walls is 400mm constructed in random rubble stone masonry. The layout plan and section of the model is given in Figs. 1 and 2

Fig. 1 Plan of model house

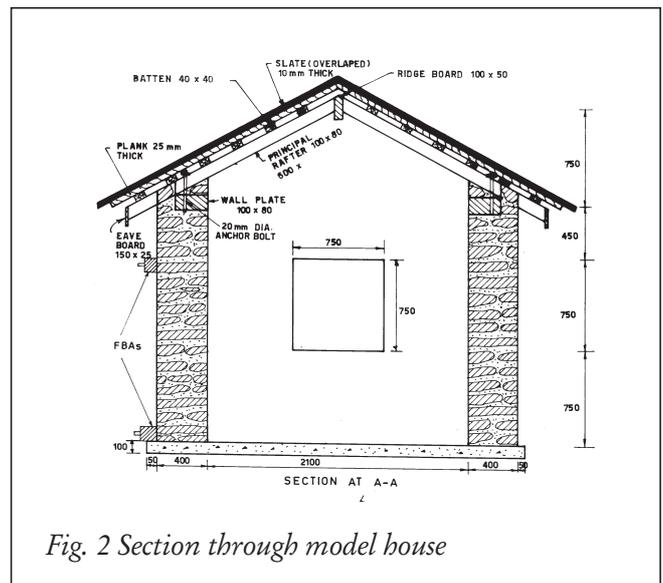
Fig. 2 Section through model house

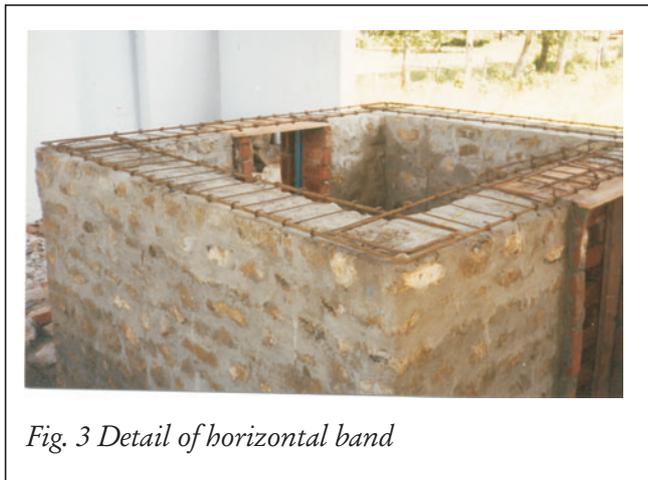
The building should be strengthened by horizontal bands or bond beams at critical levels and vertical reinforcing bars at corners and junctions of walls. The bands form a horizontal framing system, which transfers the horizontal shear, induced by the earthquakes from the walls normal to the direction of shaking to structural walls parallel to the shaking, and it also connects all the structural walls to improve integral action. In combination with vertical reinforcement, they improve the strength, ductility and energy dissipation capacity of masonry walls. Fig. 3 shows the details of horizontal bands at the level of the roof, lintel and sill. Fig. 4 furnishes the details of providing the vertical reinforcement in stone masonry.

Fig. 3 Detail of horizontal band

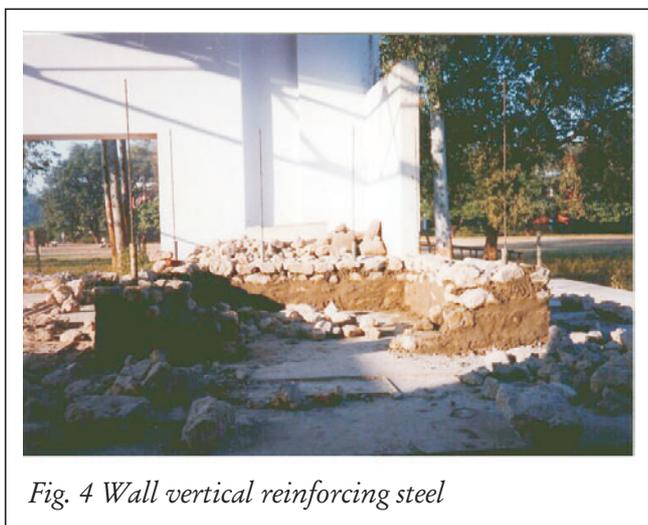
Fig. 4 Wall vertical reinforcing steel

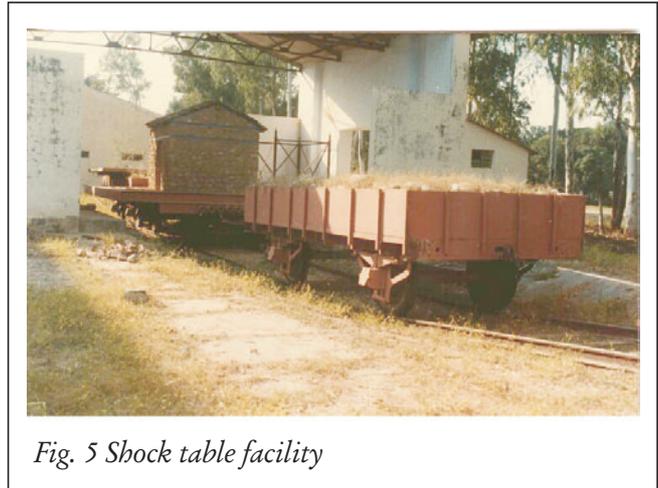
The loaded wagons are placed on the track on both sides of the shock table. One of the loaded wagons is allowed to roll down the gentle incline, impact through springs and thus drive the shock table into collision with the other dead-load wagon. The general arrangement of the shock table and its signature of shock are given in Figs.5 and 6.

Fig. 5 Shock table facility

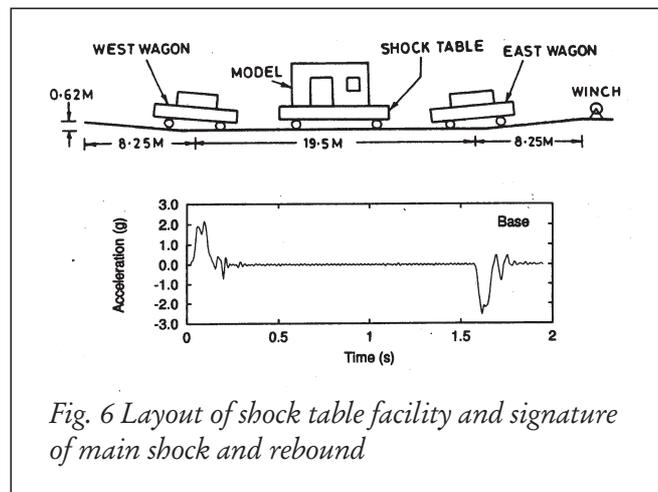
Fig. 6 Layout of shock table facility and signature of main shock and rebound

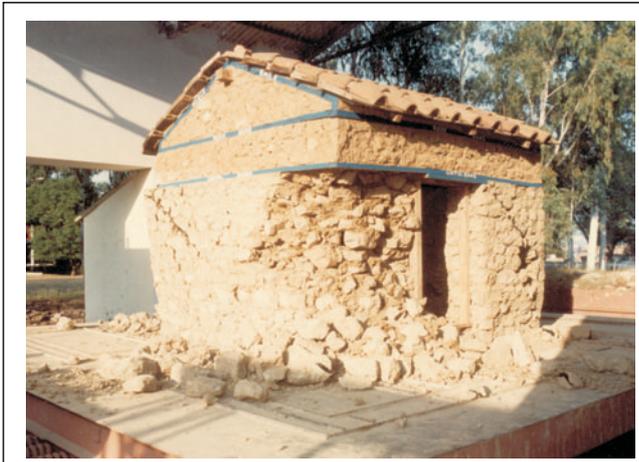
*Fig. 7 Partial collapse below lintel band*

- Code provisions are effective in reducing the damage mainly above lintel level. Brittle shear failure in wall piers still occurs but can be

reduced by providing an additional horizontal band, preferably at sill level. The vertical reinforcement at the corner of the model, in combination with horizontal bands increases the strength of the model as well as reduces cracking at corners.

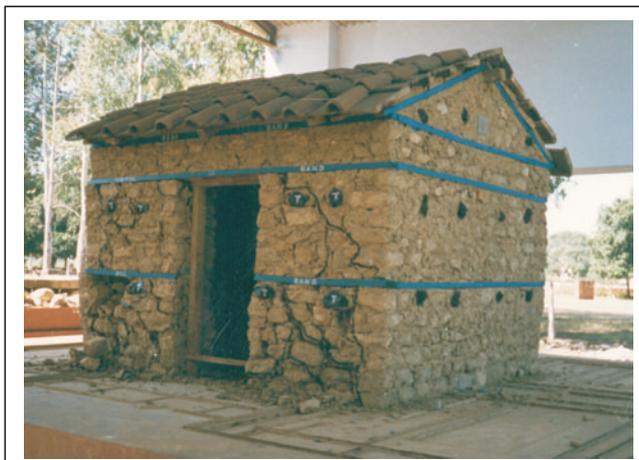
*Fig. 8 Positive action of bands reduces damage sharply*

- The provision of a seismic band at lintel level is the minimum requirement to prevent the collapse of the house in random rubble stone masonry models made in mud or cement sand mortar. The mere use of rich mortar without any other earthquake resistance measure is not adequate to prevent collapse of structures.
- The injection of cement grout in localized damaged areas can restore the original strength and stiffness. The scheme of repair involving stitching of corners of walls avoids delamination of walls during shock test.
- The external binding scheme of retrofitting is effective for increasing the strength beyond that of the original system, as cracks in the retrofitted models occur in new positions instead of the regions of previous cracks. The introduction of external horizontal tie bars helps reduce further cracking because of the ties

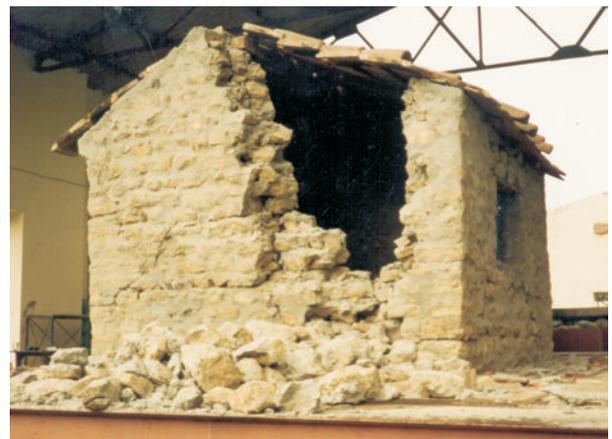
*Fig. 9 Unstrengthened house of cement-sand mortar*

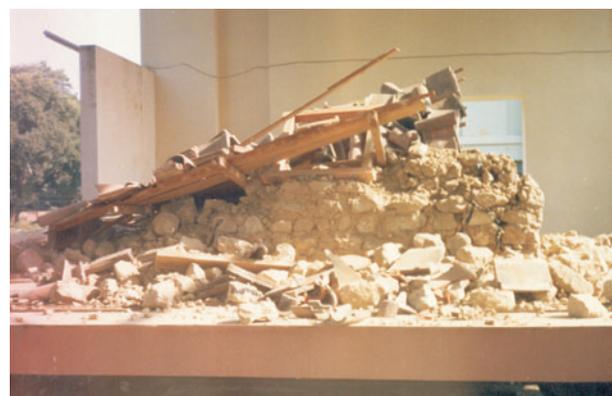
*Fig. 10 Unstrengthened house constructed with mud mortar*

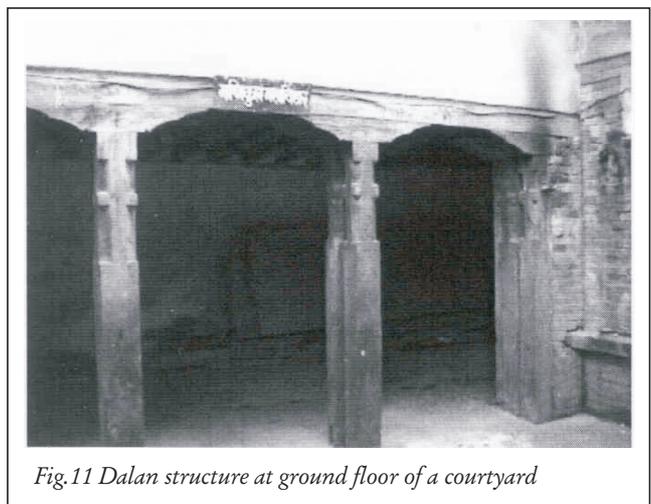
Among the many striking timber construction details of traditional buildings in the Kathmandu Valley, the *dalan* is certainly the most obvious and interesting in structural terms (Fig. 11)

The *dalan* is a timber frame made of columns, surmounted by capitals which bear double beams. The two adjacent

Fig.11 *Dalan* structure at ground floor of a courtyard

timber frames are usually connected only at the level of the beam. The *dalan* is most commonly found at the ground floor of the main façade of buildings in which the front

room is used as shop or workshop. It is also common in upper storeys as an internal structure in place of the spine wall. The columns usually have a square cross section of between 100\*100 mm and 150\*150 mm.

The *dalan* usually spans most of the width of the building with only small masonry piers of about 200 mm width restraining it laterally and connecting it to the rest of the masonry box.

In seismic terms the *dalan* is very weak for lateral loads, as all connections are simply pinned; the only lateral restraint, when present, is represented by the shear and bending strength of the masonry piers at the edge of the façade.

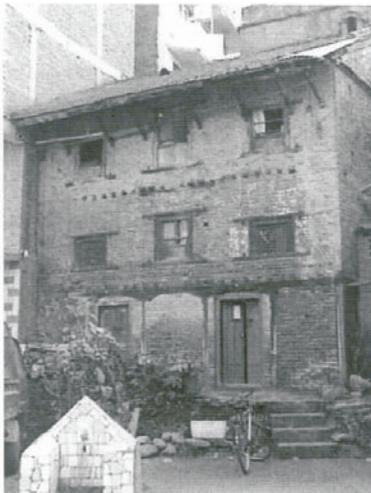
Window openings vary in size depending on the period of construction. The older buildings have generally smaller squared windows with lintels extending well into the surrounding masonry. These also are usually built with a double frame. The size of the windows within a storey may vary depending on the use of the room. Figs. 12 and 13 show different window layouts.

Fig. 12 Different size of windows at same floor

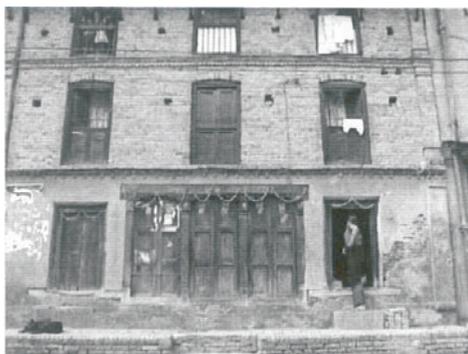
Fig. 13 Whole height windows

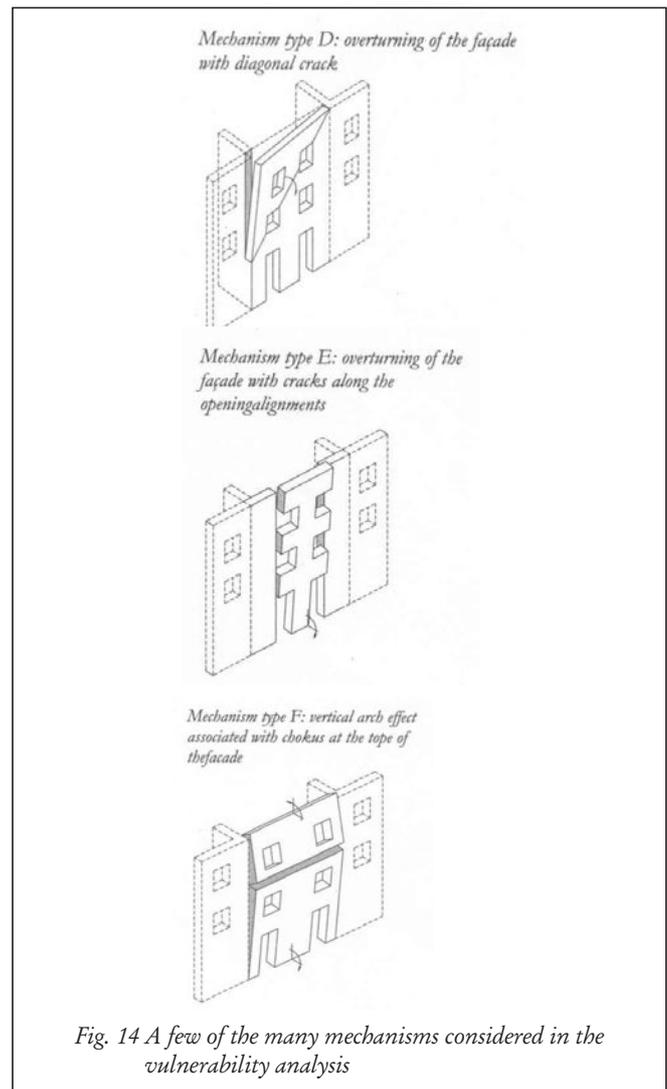
A computer program, based on input from a detailed survey of each building predicts the ultimate lateral load factor (% of gravity acceleration *g*), which will trigger the onset of a specific failure mechanism (Fig. 14). It is possible to predict possible damage modes and levels of vulnerability for individual or groups of buildings in relation to expected levels of shaking at the site. It is also possible to analyse the reduction in vulnerability obtainable by introducing selected types of strengthening.

Fig. 14 A few of the many mechanisms considered in the vulnerability analysis

- Buildings with dalan are extremely vulnerable unless there is appropriate masonry restraint at the sides of the dalan structure. These façades need to be strengthened
- Façades with poor lateral connections and no visible presence of pegs are highly vulnerable, as they are prone to overturning over their whole height, causing the floor structure to collapse. The introduction of chokus at roof and possibly floor levels would consistently reduce the vulnerability from high to medium.
- Façades with basically good construction standards, such as good maintenance of the masonry accompanied by connection to party walls and presence of chokus at roof level, all show medium-low level of vulnerability.
- Well-built buildings will have high collapse load factors associated with global collapse mechanisms, typically in the range 0.40 to 0.60 a/g.

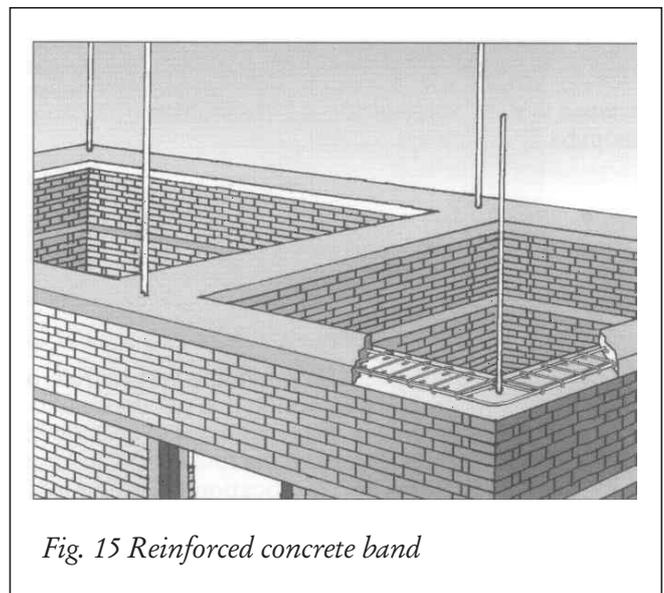
Fig. 15 Reinforced concrete band

Although set in the context of Nepal, this 63 page manual, plentifully illustrated (Fig. 15 for example) and attractively presented, is relevant to all other seismic areas with similar construction materials and methods.
