EARTHQUAKE HAZARD CENTRE NEWSLETTER

Vol.5 No.4

APRIL 2002

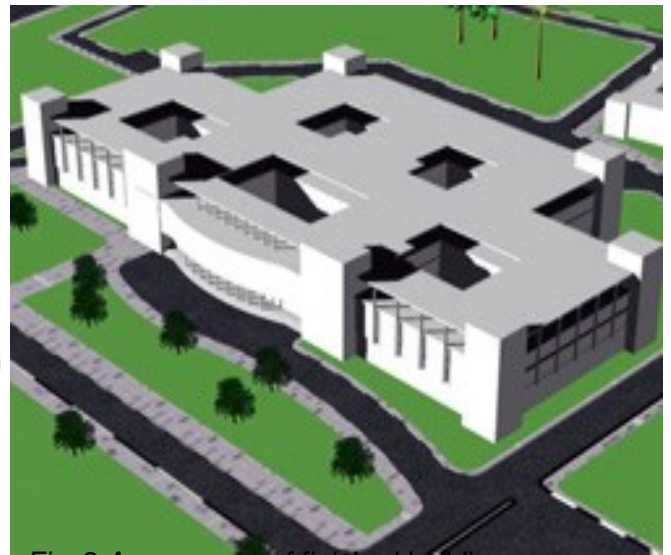
Fig. 2 Appearance of finished building

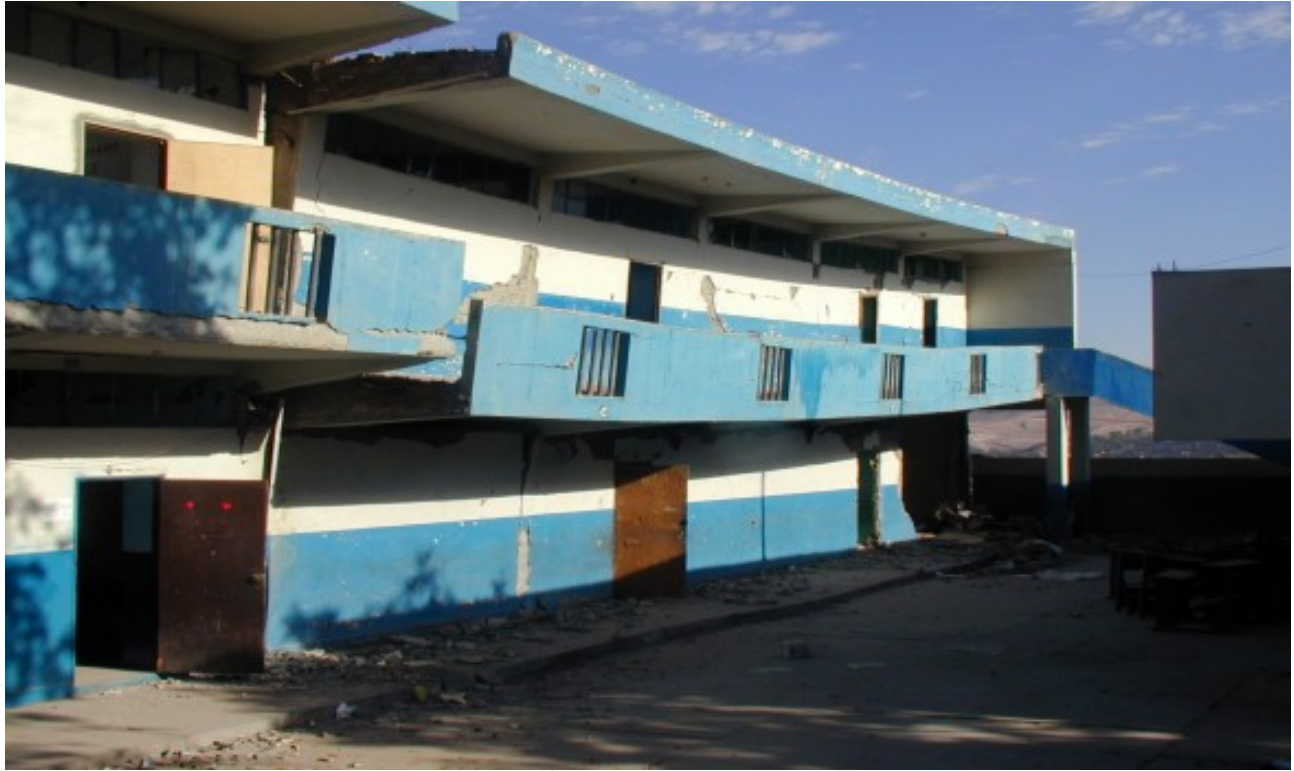
Fig.6 School building in Moquega. Partial collapse due to short column failure

The damage there is mainly to old and new adobe houses. Numerous adobe buildings collapsed in the downtown area, and many others sustained heavy damage to the point of being almost unstable. In the area of San Fransisco, the hillside was nearly totaled due to collapse of new adobe houses. One school had a partial collapse due to short columns (Fig.6)
