EARTHQUAKE HAZARD CENTRE NEWSLETTER

Vol. 20 No.2

OCTOBER 2016

Summary of Damage Observed in Tarqui, Manta

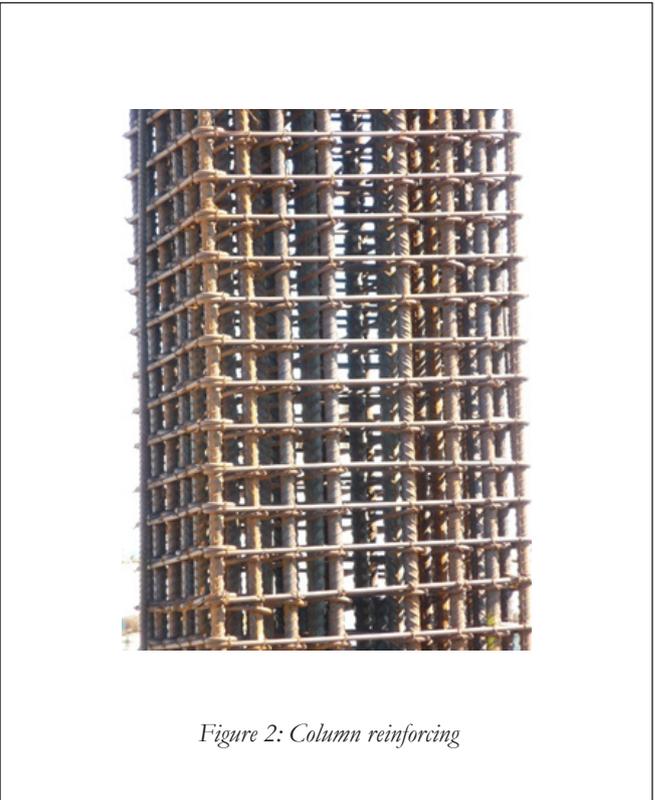
Figure 2: Column reinforcing

The column is obviously very strong in bending as a consequence of the large number and size of longitudinal bars. The square cross-section of the column and the well-distributed longitudinal reinforcement around its perimeter suggests this column is part of a two-way frame. In this case the column will be subject to bi-axial bending. As well as possessing high bending strength, the shear strength is also very high throughout the entire height of the column. Ties are closely-spaced and at each level of ties, eight legs pass through the column. The legs not only contribute to shear strength, but also prevent the longitudinal steel bars buckling when the cover concrete is lost during a damaging earthquake. Note that the ties all have 135 degree bends to maintain effectiveness even without cover concrete. See if you can find where the steel fixers have left out a tie!

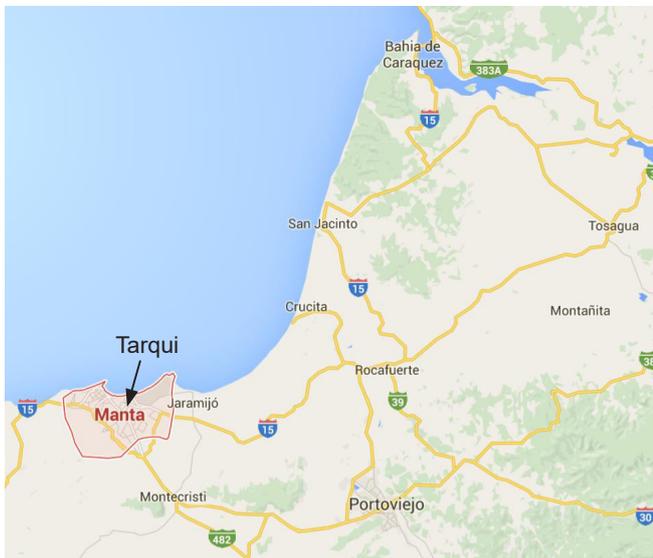
- 20 miles from Portoviejo
- Population 221,000
- 5th most populous city in Ecuador
- 4-5 storey RC frame building with masonry infill walls
- Many residential buildings or hotels with retail on ground level
- Typical floor extends over sidewalk

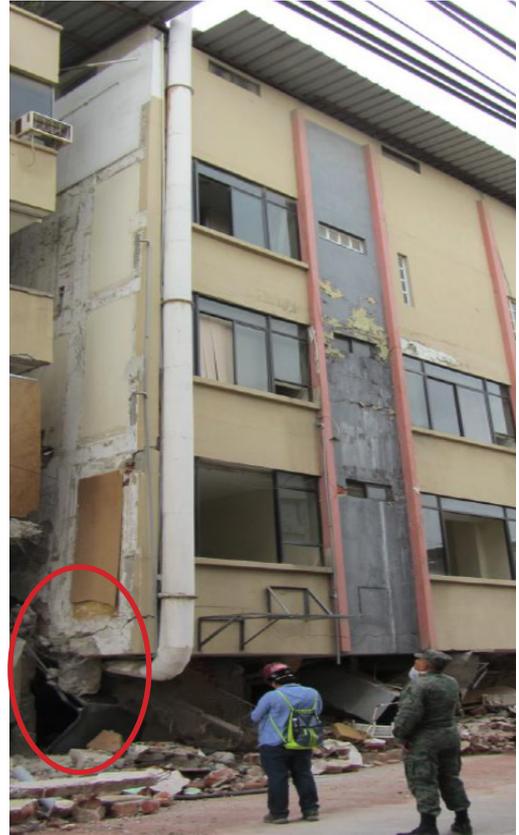
11th Ave and 2nd St

4 storey RC frame building with masonry infill walls.

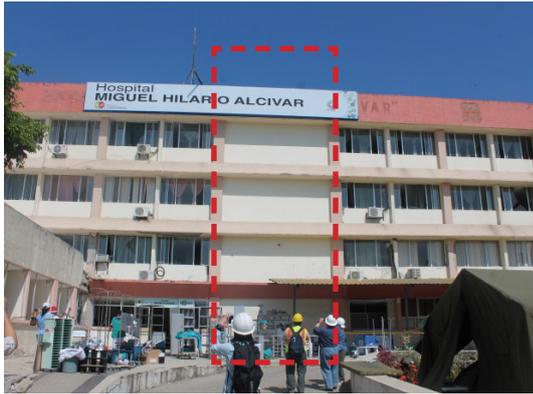
- This hospital was retrofitted in 2000 after a M7.2 earthquake in Bahia in 1998
- Part of the seismic retrofit included the cast of 6 shear walls, and jacketing of some concrete columns at the perimeter

Front view. Shear wall marked.

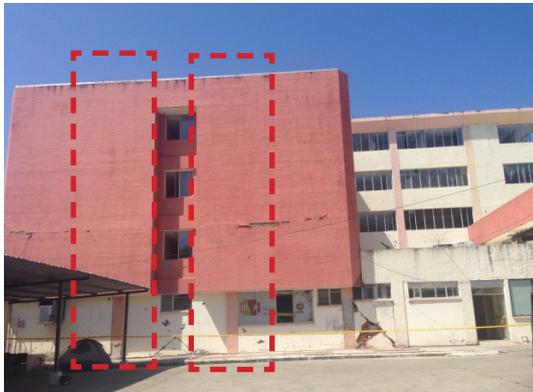
Lateral view. Shear walls marked.

Severe cracking of URM walls was observed in the 1st floor; however, several of these walls did not fall down towards the ground. Smaller drifts due to rigidity of shear walls might have influence on this behaviour?

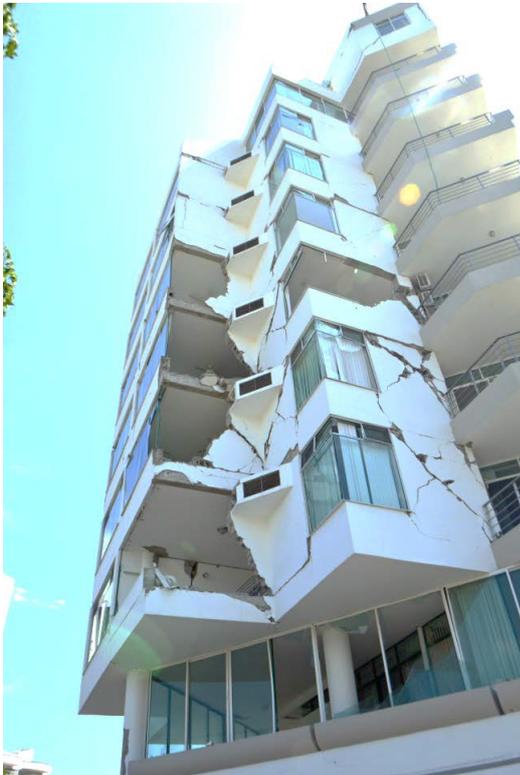
- Generally buildings are RC up to 10 storeys older units: flat slabs or waffle-slabs on columns newer units: girder-column frames, RC floors shear walls are not used
- Building occupancy in coastal area: apartments / hotels hospitals government buildings few office buildings
