# EARTHQUAKE HAZARD CENTRE NEWSLETTER

Vol.15 No.4

APRIL 2012

## A summary of “the EERI Special Earthquake Report - April 2012 - The $M_w$ 7.1 Erciş-Van, Turkey Earthquake of October 23, 2011”, by Rafael Alaluf, Ricardo Hernandez, Cemalettin Dönmez and Ayhan İrfanoğlu.

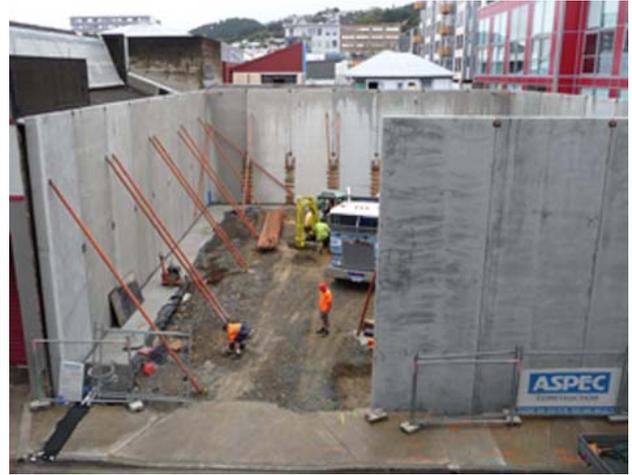
As we visit this site we can see the precast panels have been placed on and connected to the foundations. Also, at about one third of their height, the panels are joined by welded plates that tie them together along their plane, effectively creating one long precast concrete shear wall. At this stage of construction the panels are very vulnerable to out-of-plane loading and so are propped until permanent structure is attached (Fig. 1)

Fig. 1 Precast concrete wall panels are propped in place.

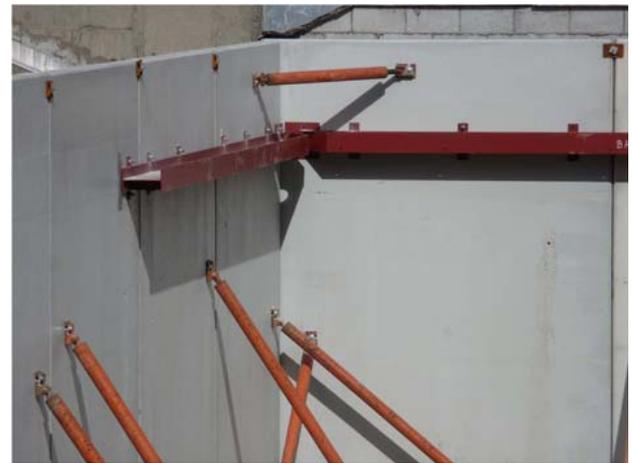
Figure 2 shows the eaves bond beam in the form of a steel I beam on its side. This beam is part of the lateral load-resisting system. First of all, it resists seismic inertia forces that occur on the top half of the panels (the bottom half of the inertia forces travel in bending and shear in the panel to the foundations). Secondly, this horizontal member will be one of the two longitudinal roof plane truss chords. The other chord runs parallel to it and is the circular tubular section located approximately half way between the wall and the roof apex (Fig. 3).

Fig. 2 Horizontal steel eaves member that functions as a roof diaphragm chord, bolted to the panels.

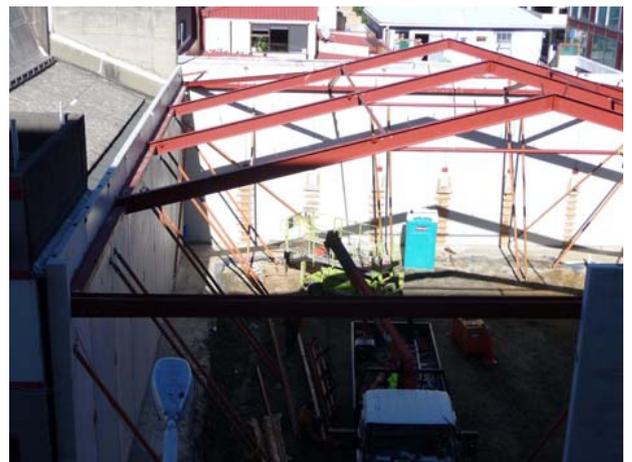
The roof plane truss is not yet complete. The steel rod cross-bracing has yet to be installed. When completed, together with the cross-bracing, the chords will form half of the cross-braced roof diaphragm. Its job is to resist half of the inertia forces from the top half of the building acting parallel to the steel roof rafters, and transfer them by truss action to the precast shear walls at rear and front of the building.

Fig. 3 Steel rafters with chords for the cross-braced steel roof diaphragm. Rod cross-bracing is yet to be installed.

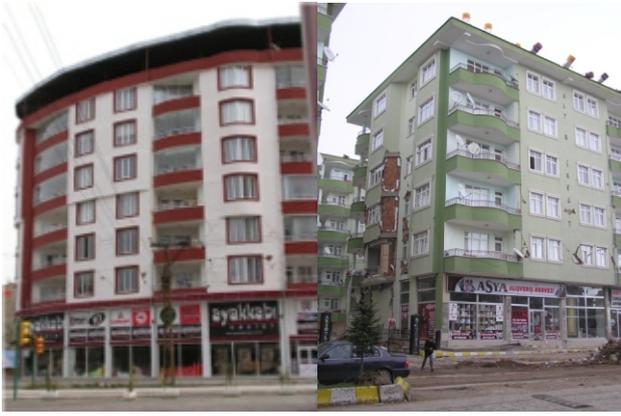
The majority of the commercial activity in the region takes place in mixed-use buildings. These structures are occupied by the commercial units at the first (ground) story and by residential units at upper stories (Fig. 5), particularly along the main streets. In older mixed-use buildings, lower stories are stripped of their partition walls because of commercial activity. In newer mixed-use buildings, lower stories are taller than upper stories and again lacking partition walls, particularly along the street

Fig. 5 Typical mixed-use buildings in Van (top) and Erciş (bottom) (photos: Dönmez, İrfanoğlu).
