EARTHQUAKE HAZARD CENTRE

NEWSLETTER

APRIL 2011

MORE LESSONS FROM CHRISTCHURCH

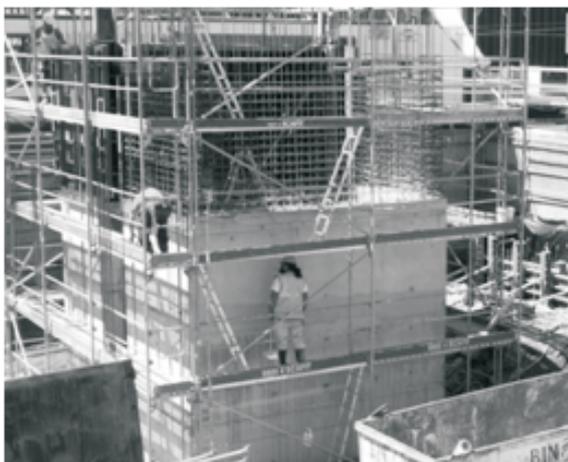
Fig.1 Central shear core two storeys high.

The building visited is a 10-storey commercial building on the outskirts of Wellington's CBD. The structural systems comprise two different systems and materials. For seismic loads acting in the longitudinal direction along the length of the building, inertia forces are resisted by the two unpenetrated walls that enclose two sides of the central shear core. Figure 1 shows one of these walls which is essentially C-shaped, since the two end return walls function as flanges to the longer "web" walls when they resist bending and shear. The shear core is connected to four large piles which are cast more than 10 m deep and provide moment fixity to base of the core.

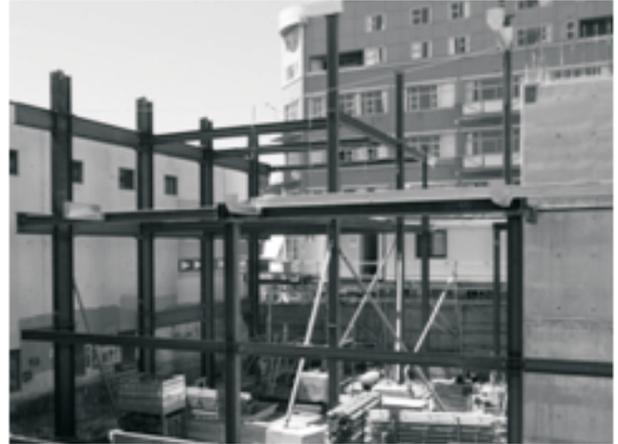
Fig. 2 Shear core to the right, a perimeter moment frame to the left and gravity-resistant structure between.

In the transverse direction two systems resist seismic load. First there are the two coupled-walls in the core. Because of door height penetrations at each floor level these walls are coupled together by strong coupling beams at each storey. In this building they are solid steel beams, designed to flex and yield in a ductile manner. If RC coupling beams were to have been specified they would have required special diagonal reinforcing steel to prevent brittle diagonal shear cracks forming under lateral loads. Because of the relative weakness of the two coupled walls as compared to the longer longitudinal walls, additional strength in the transverse direction is provided by two moment frames, one at each end of the building (Figures 2 and 3). Not only do they resist a sizeable proportion of the transverse forces acting on the building, their other structural role is to withstand building torsion. The small dimensions of the core make it unable to resist torsion all by itself, so with two moment frames separated by the whole length of the building, that long lever-arm together with the strength of the frames ensures very stable resistance against torsion.

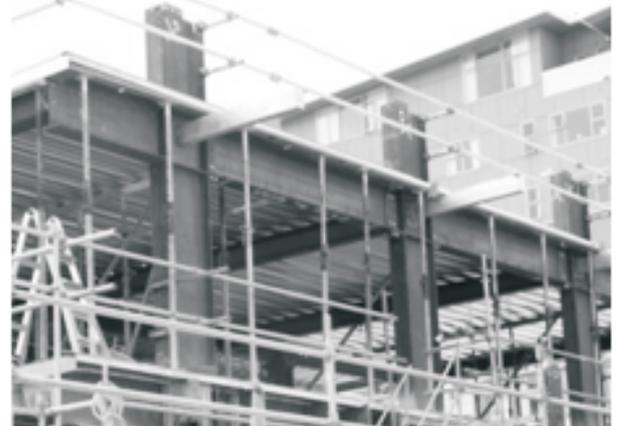
Fig. 3 Two of the three bays of an end steel moment frame.

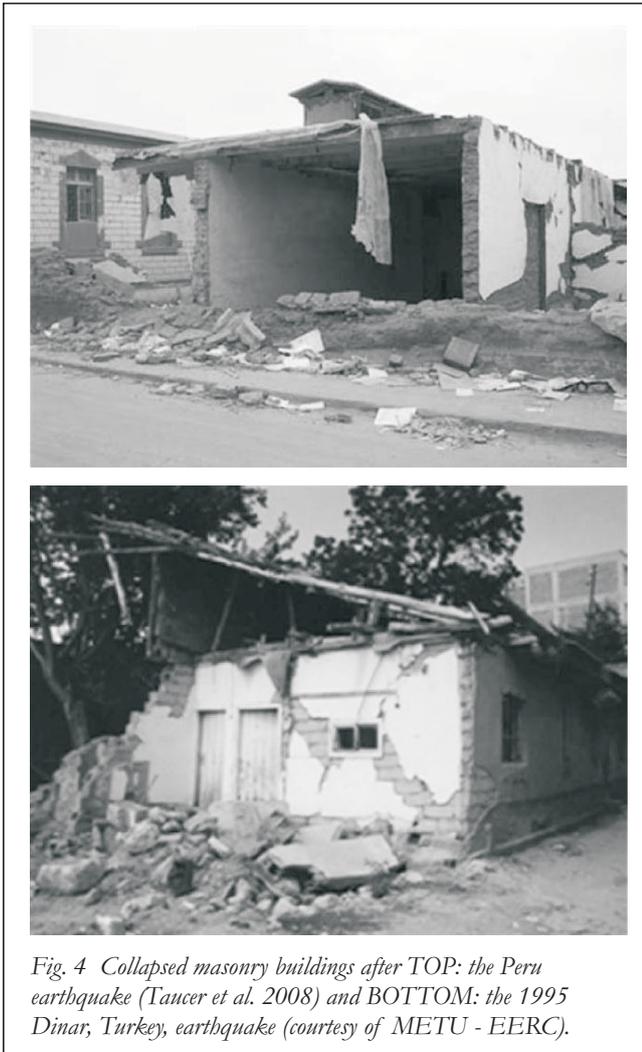
Fig. 4 Collapsed masonry buildings after TOP: the Peru earthquake (Taucer et al. 2008) and BOTTOM: the 1995 Dinar, Turkey, earthquake (courtesy of METU - EERC).

1995 Dinar earthquake, it was observed that irregular buildings suffered localized damage and collapses due to torsional effects.

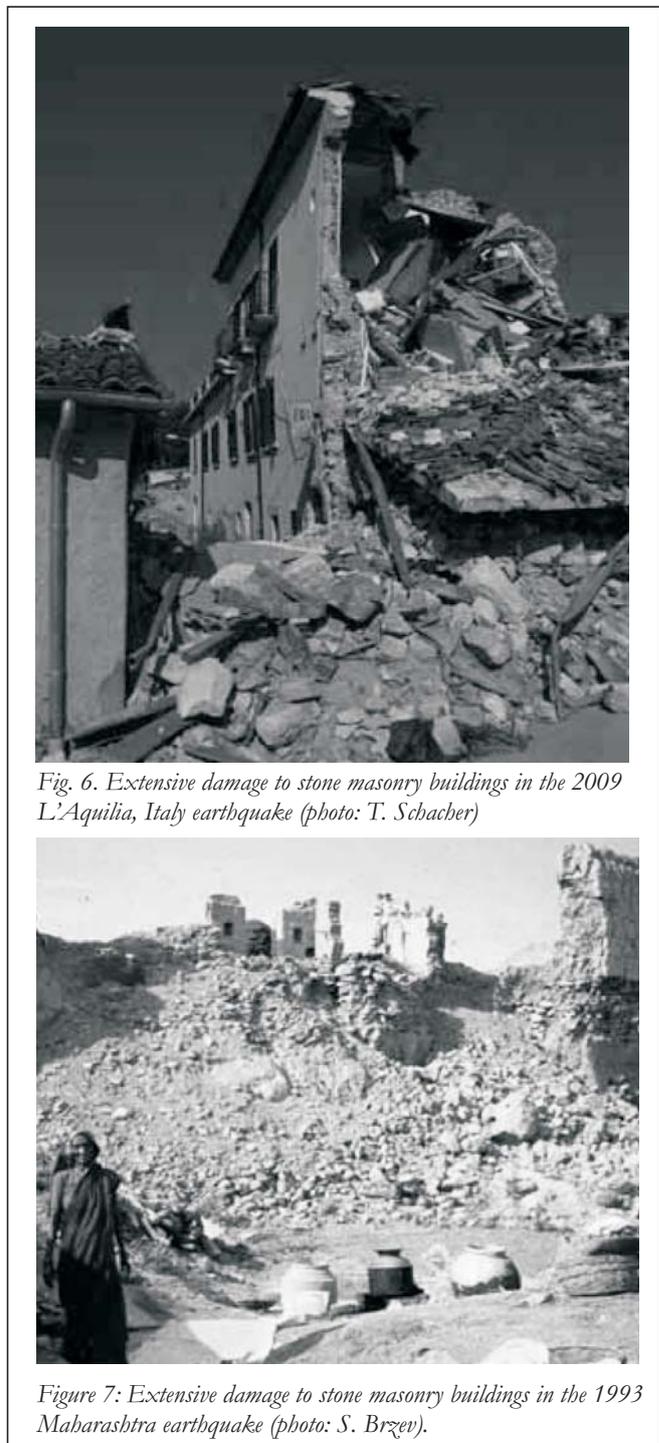
Fig. 6. Extensive damage to stone masonry buildings in the 2009 L'Aquila, Italy earthquake (photo: T. Schacher)

Figure 7: Extensive damage to stone masonry buildings in the 1993 Maharashtra earthquake (photo: S. Brzev).

Stone masonry buildings have shown poor performance in past earthquakes, leading to significant human and economic losses. This includes performance in earthquakes in Italy, Greece, Turkey, Montenegro, Slovenia, Algeria, Iran, Pakistan, India, Nepal, and many other countries. In the 2005 Kashmir earthquake (M 7.6), over 74,000 people died in Pakistan, most of them buried under the rubble of traditional stone masonry dwellings. In India, most of the 13,800 deaths during the 2001 Bhuj earthquake (M 7.7) and more than 8,000 deaths in the 1993 Maharashtra earthquake (M6.4) were attributed to the collapse of this type of construction. Examples of devastation caused by heavy damage or the collapse of stone masonry buildings in past earthquakes are shown in Figures 6 and 7.

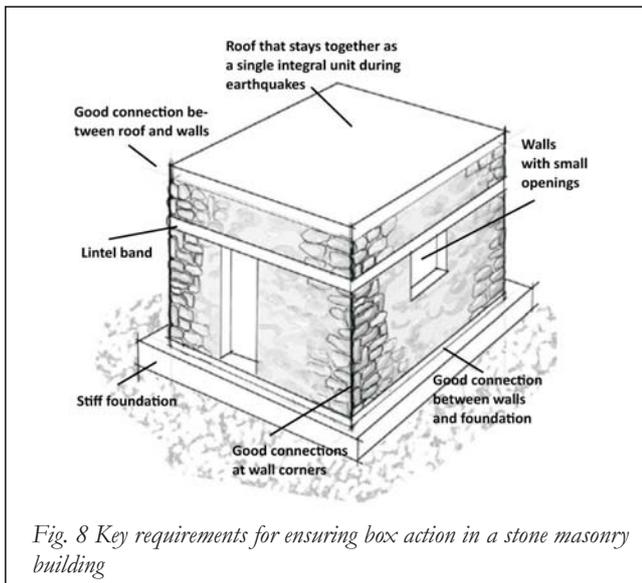
Fig. 8 Key requirements for ensuring box action in a stone masonry building

STRUCTURAL INTEGRITY (BOX ACTION)
 Past earthquakes have shown that the damage of unreinforced masonry buildings is significantly reduced when building components are well connected and a building vibrates like a monolithic box, as discussed in

Chapter 2. In many cases, unreinforced masonry buildings have flexible floors, so there is a need to provide additional elements to tie the walls together and ensure acceptable seismic performance. Structural integrity of a building can be achieved by developing a box action, that is, by ensuring good connections between all building components—foundations, walls, floors, and roof. Key requirements for the structural integrity in a masonry building are illustrated in Figure 8. A ring beam (band) at lintel level is one of the critical provisions for ensuring structural integrity.

A seismic band is the most critical earthquake resistant provision in a stone masonry building. A band, usually provided at lintel, floor and/or roof level in a building, acts like a ring beam or a belt, as shown in Figure 8. Seismic bands are constructed using either reinforced concrete (RC) or timber. Proper placement and continuity of bands and proper use of materials and workmanship are essential for their effectiveness.
